The meeting started at 9:30 on 12/30/2022

**ISLAND PARK - #000074**

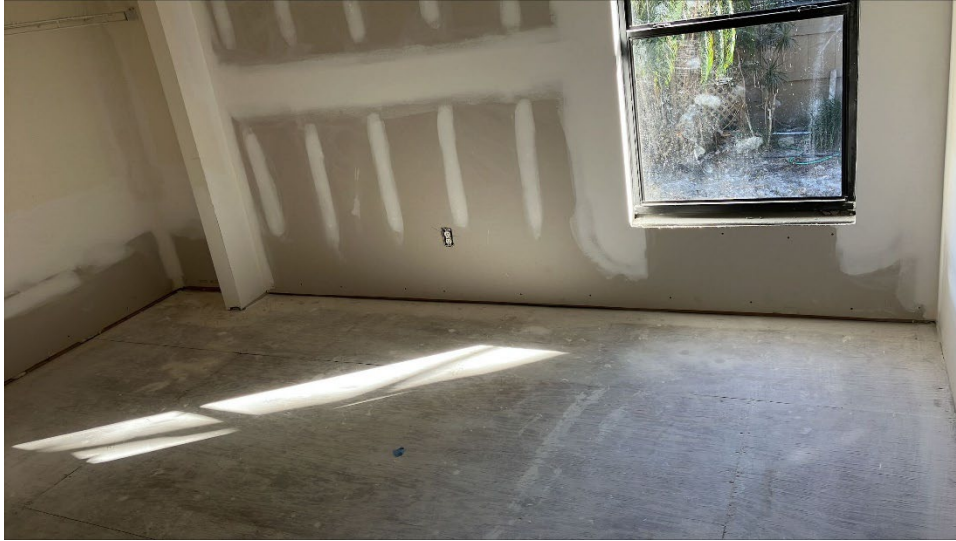
Subfloor in guest bedroom loose

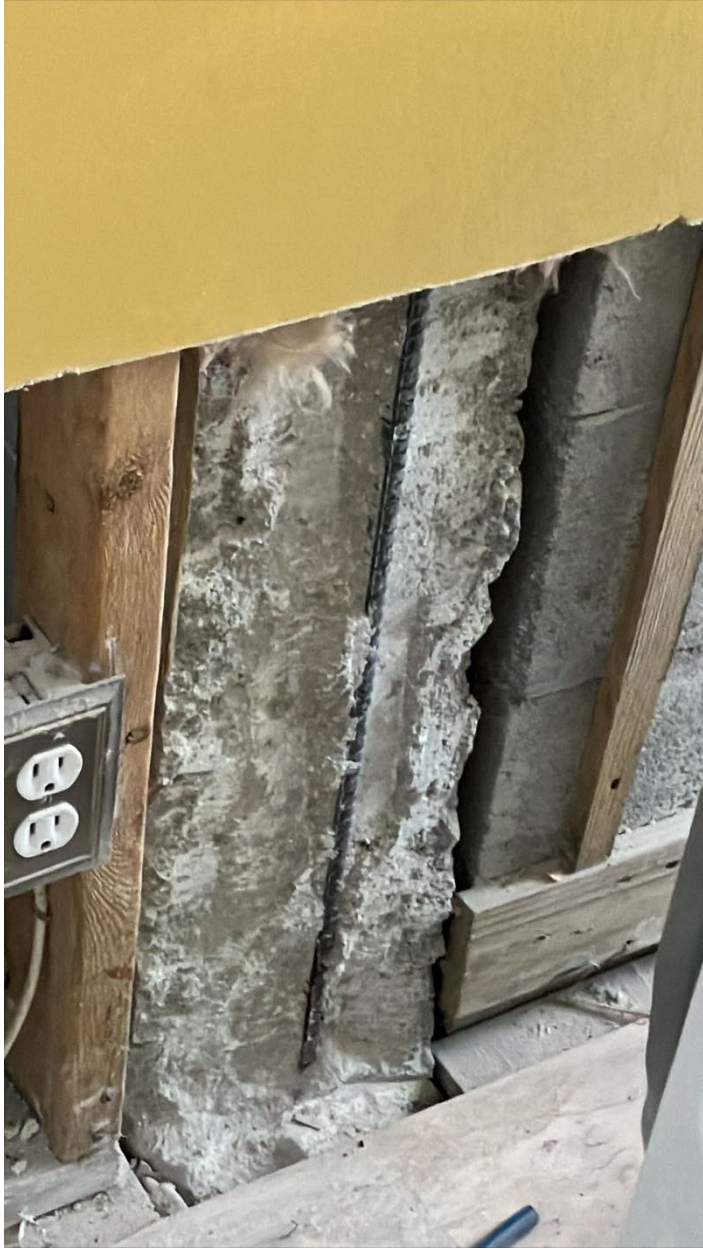
Exposed rebar in kitchen column ??

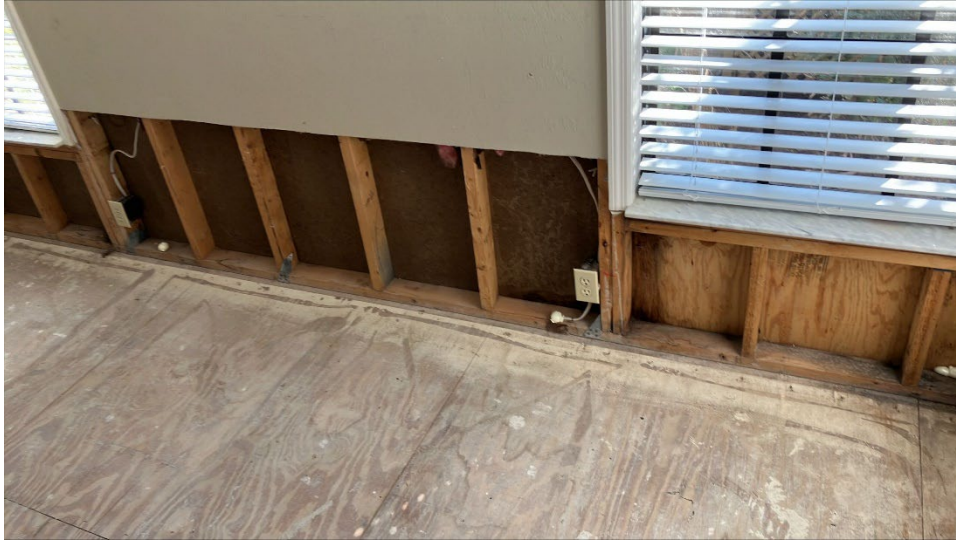
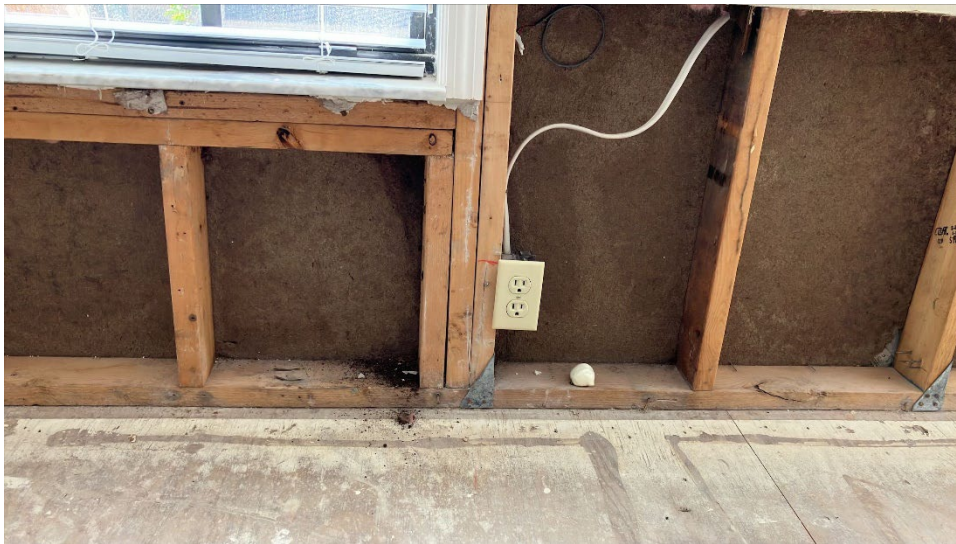
Dining room area, rotting subfloor

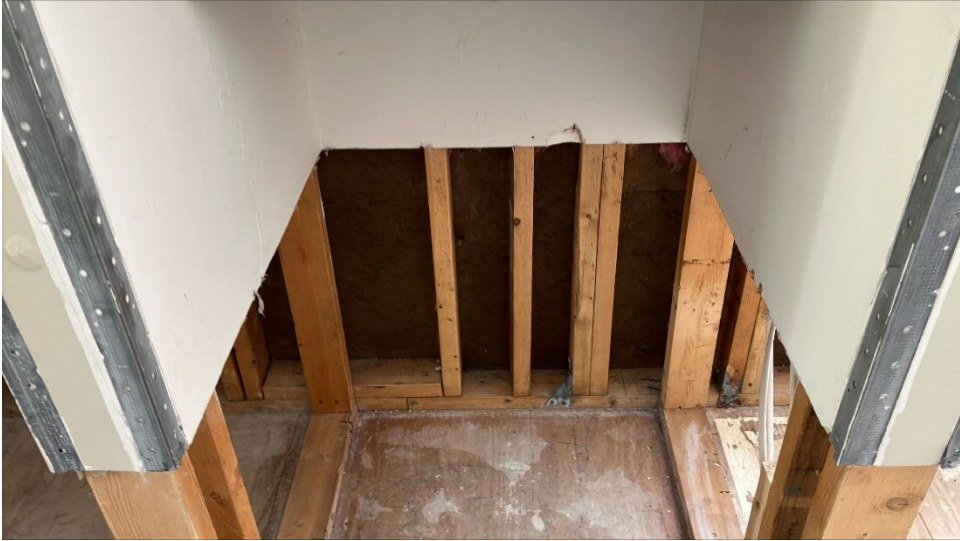
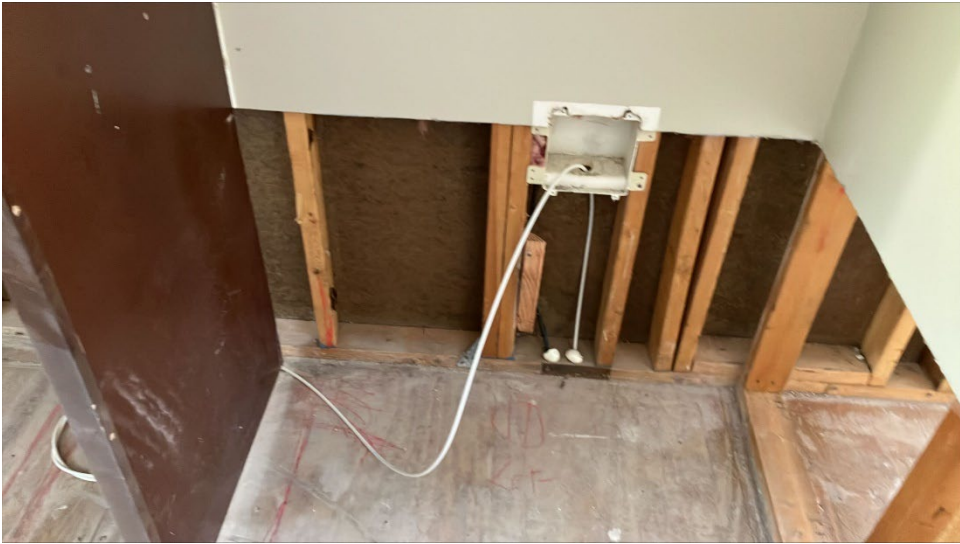
Water damage in sheathing dining room area

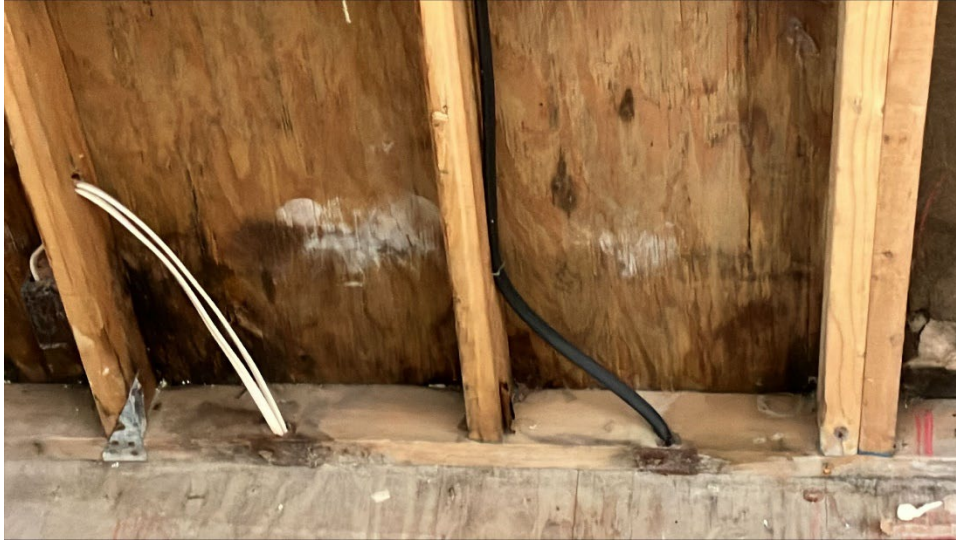
Water damage on plywood exterior in kitchen area

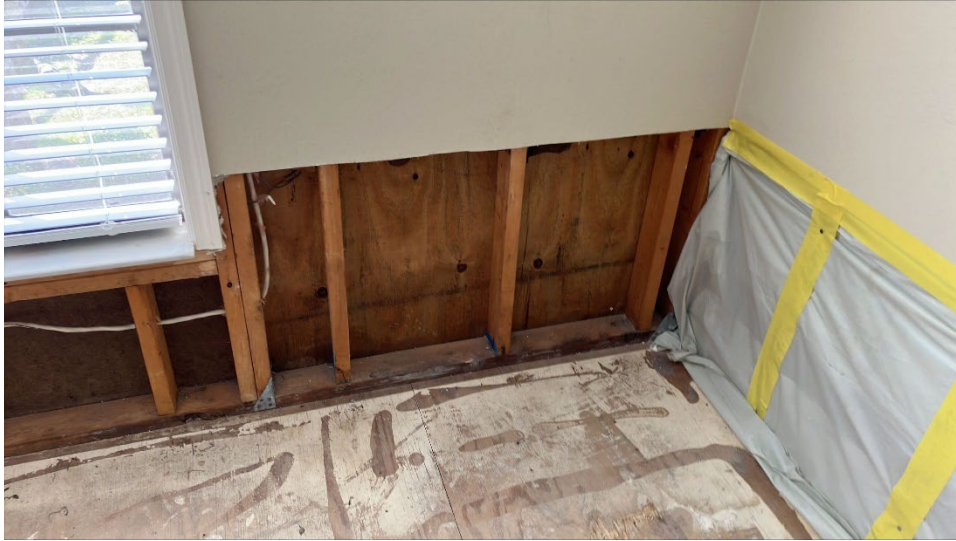
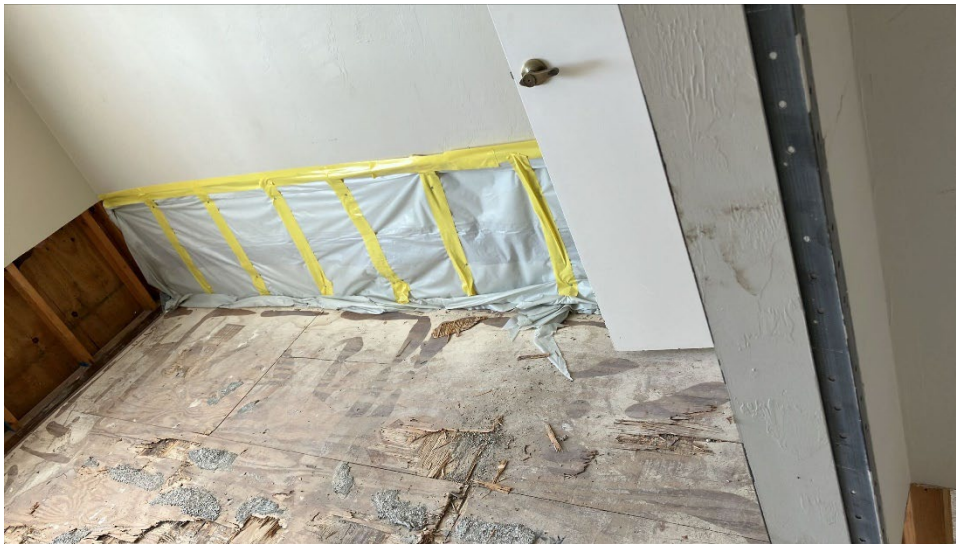
Wood sheathing has water damage

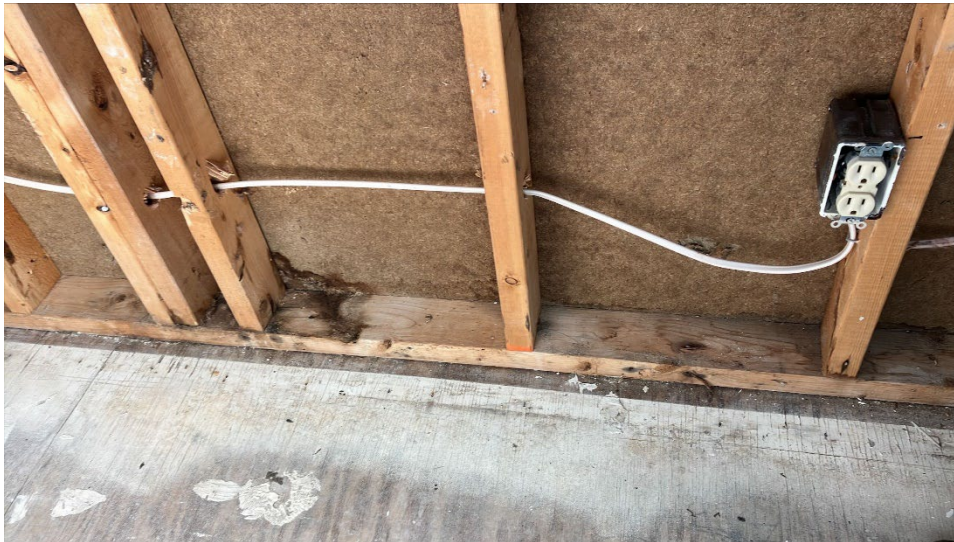
Water damage on wall and frame

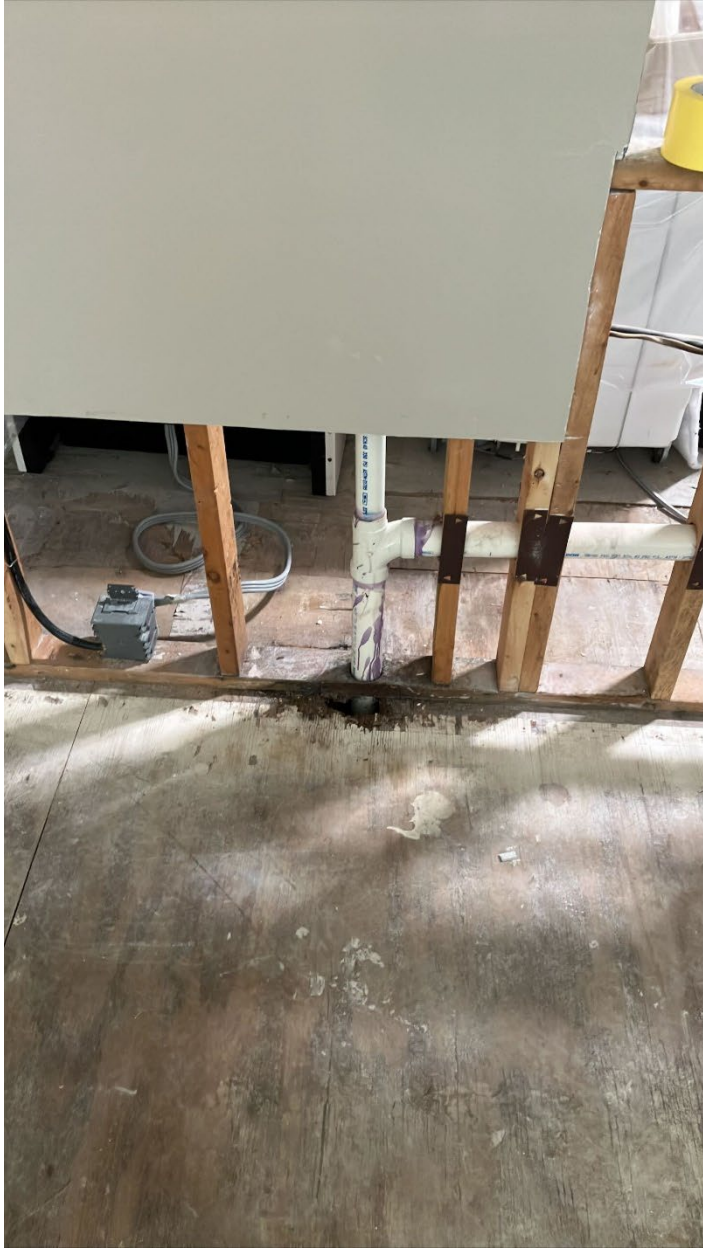
Back side of sink wall facing the living room there is floor rotting

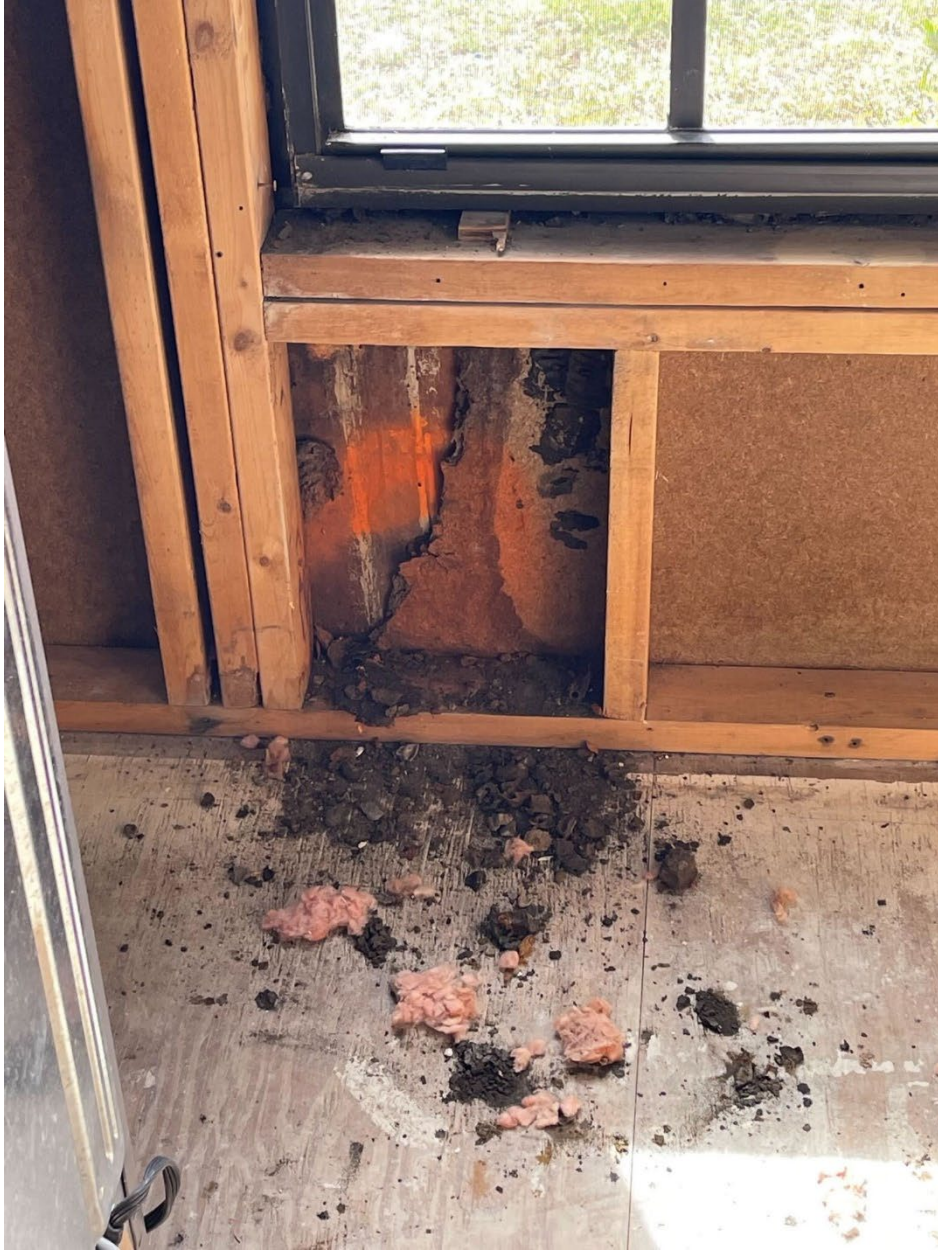
Under living room window, wood sheathing

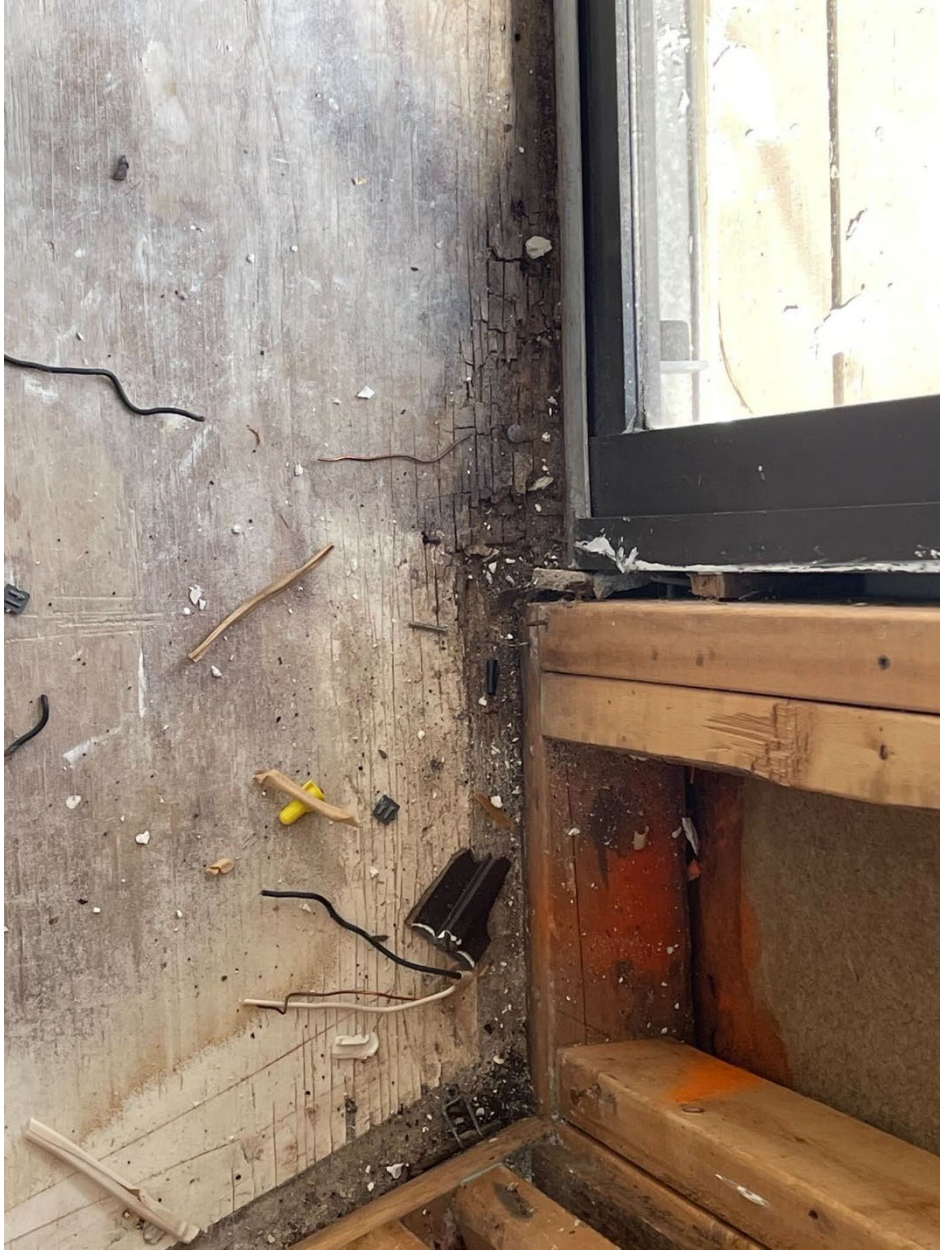
Left and right side of the floor and wood sheathing next to sliding glass door and several other spots in master bedroom.
