The meeting started at 9:30 on 12/30/2022

**ISLAND PARK - #000074**

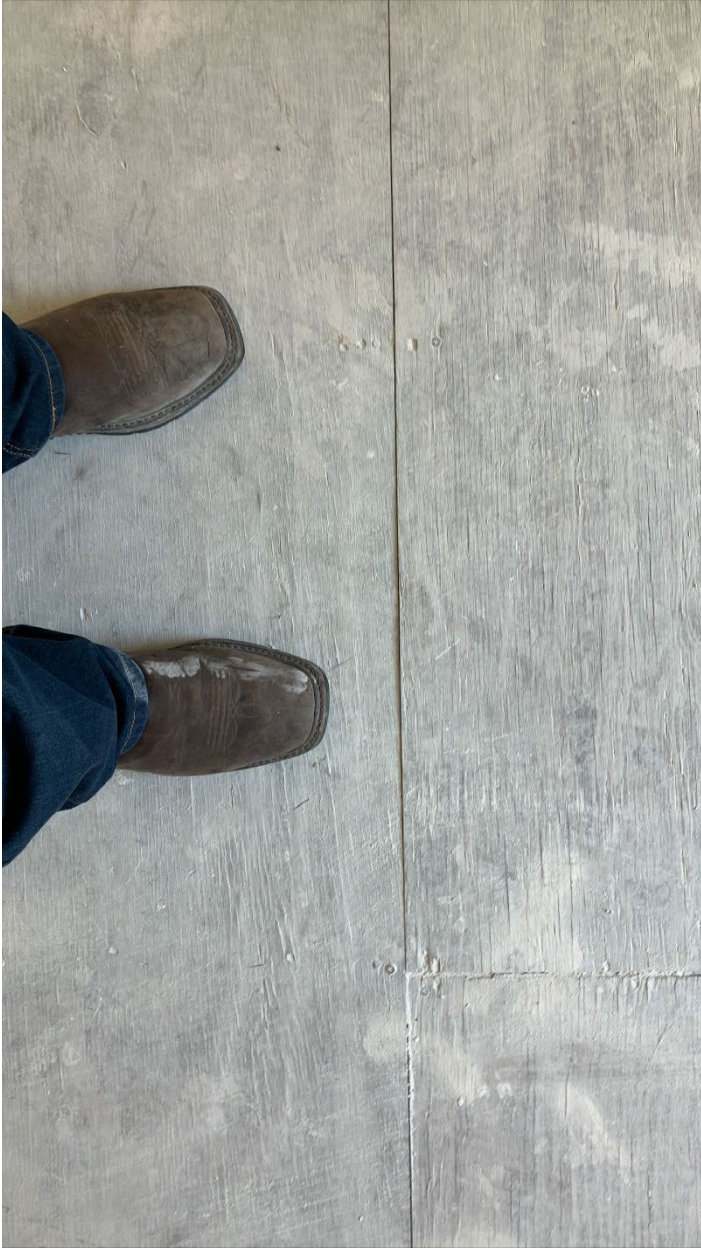
The condition of the subfloors may be an issue. Need engineering to determine the quality of subfloor. Iphone stated each unit is different. Week of January 3, Elias will visit each unit to determine subfloor status. If new subfloor required, Elias will reinstall subfloor, then drywall. If a unit owner doesn't want to replace subfloor, Elias will require owner to sign waiver to protect HOA. Jim asked why a waiver. Elias said only if subfloor is required to be removed and owner refuses.

Elias said they will inspect floors of two or three units to determine if they need to be removed. If the results determine they need to be replaced, then Elias will expand testing to other units. If the three units come back good, then Elias will make a decision on further testing. Elias can't set a date for replacing subfloors. If an owner doesn't want to replace a bad subfloor, they must sign a waiver. Engineering will do the tests on the three units, if plywood is healthy, then Elias will inform the owners. Jim said not all homes in question need subfloors.

Subfloor in guest bedroom loose

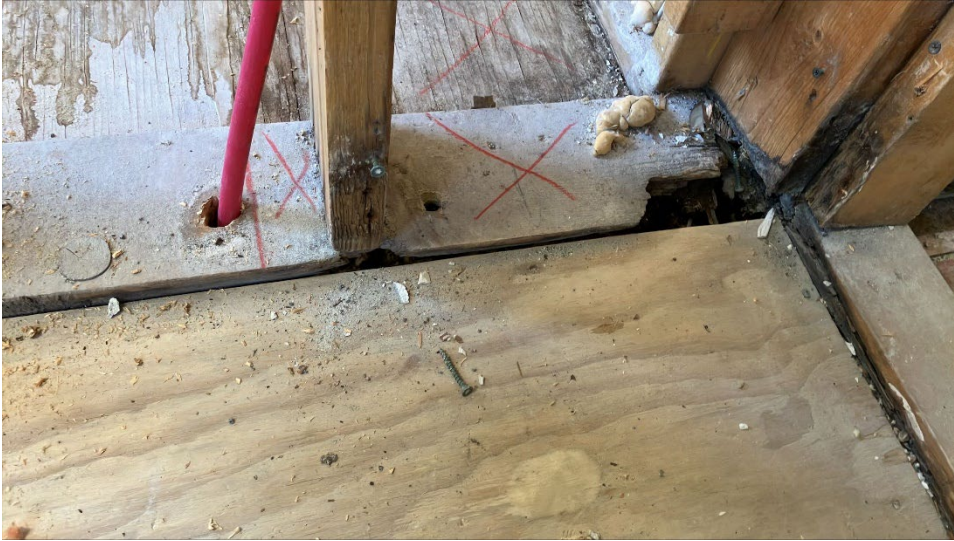
Completely rotted to 2x4 Frames and subfloor

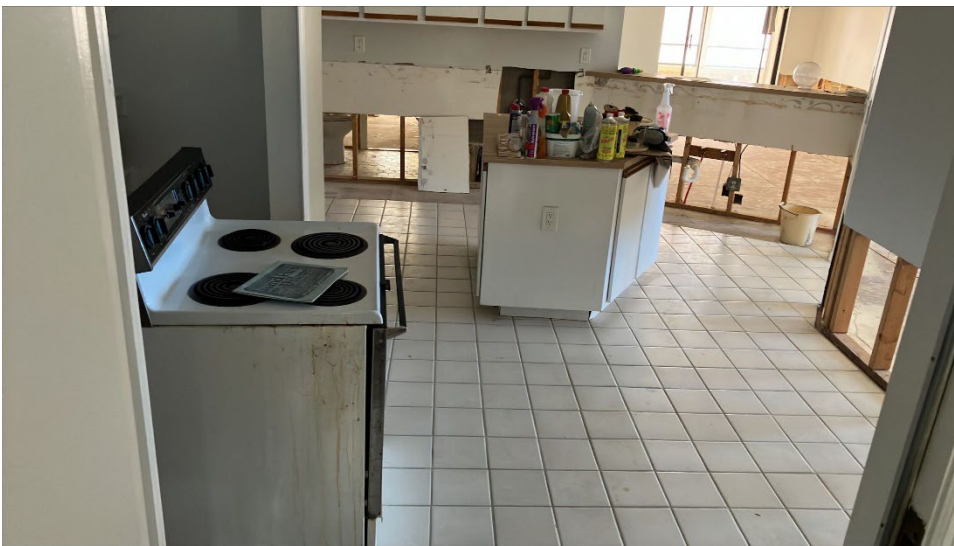
Kitchen sub floor removal

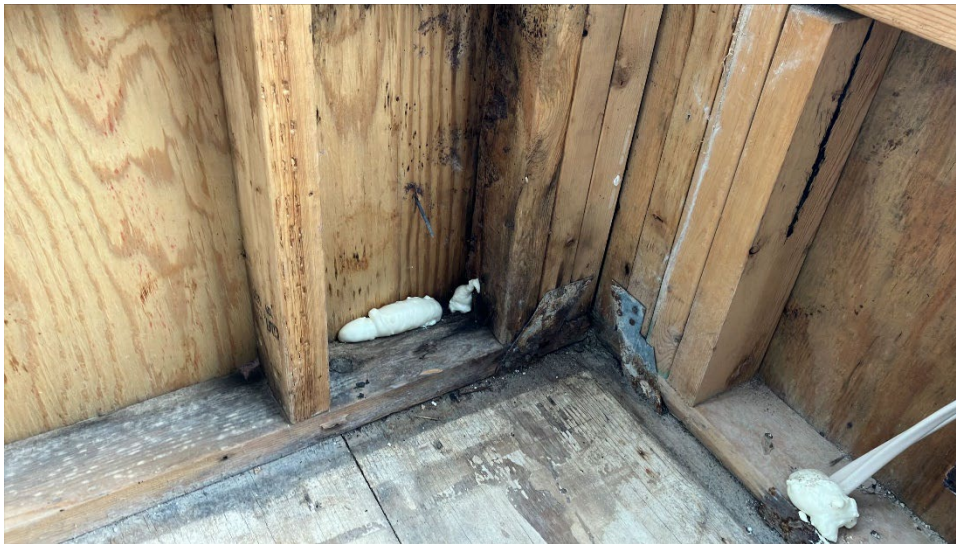
Dining room area, rotted, framing

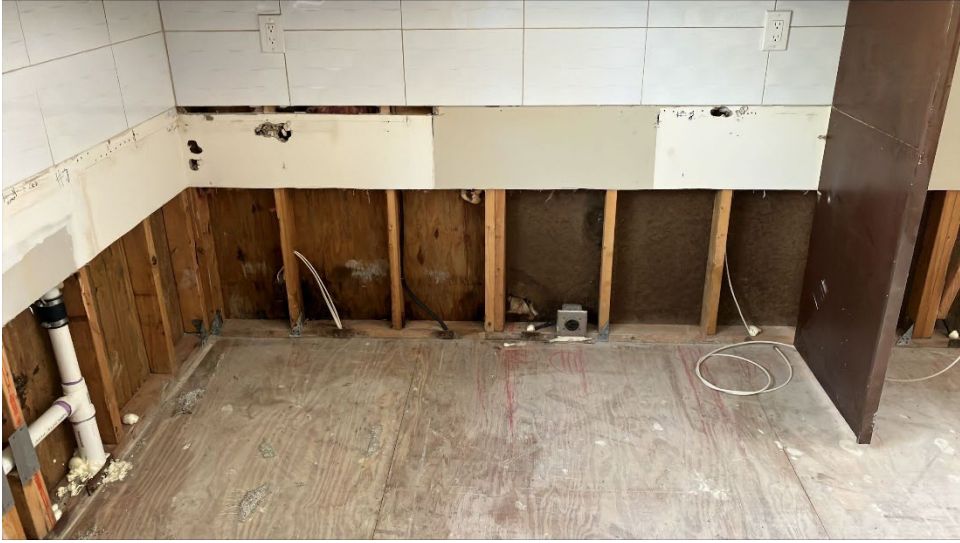
Kitchen where the fridge went
