The meeting started at 9:30 on 12/30/2022

**ISLAND PARK - #000074**

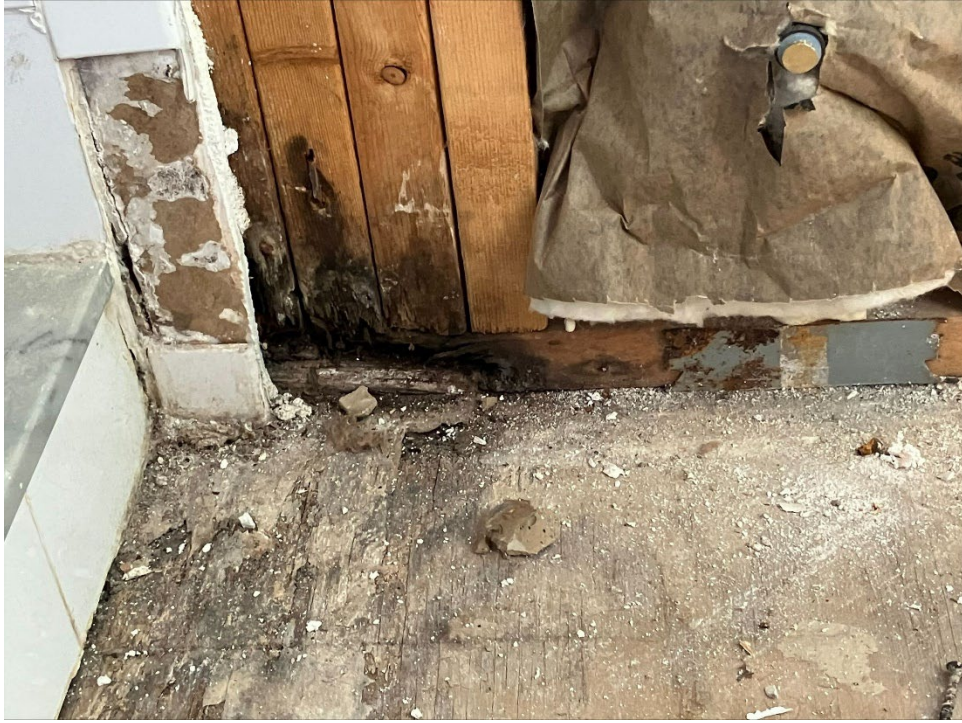
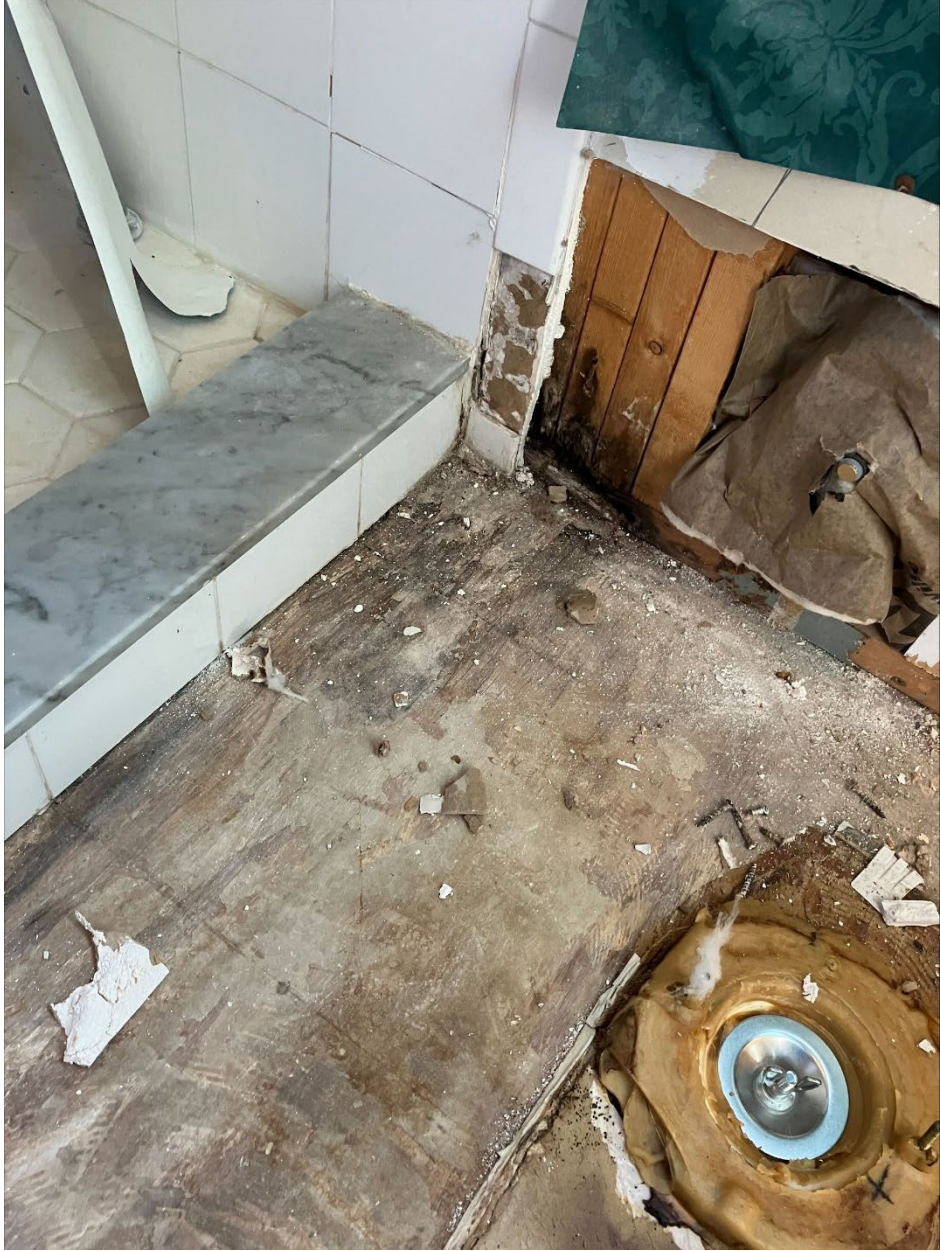
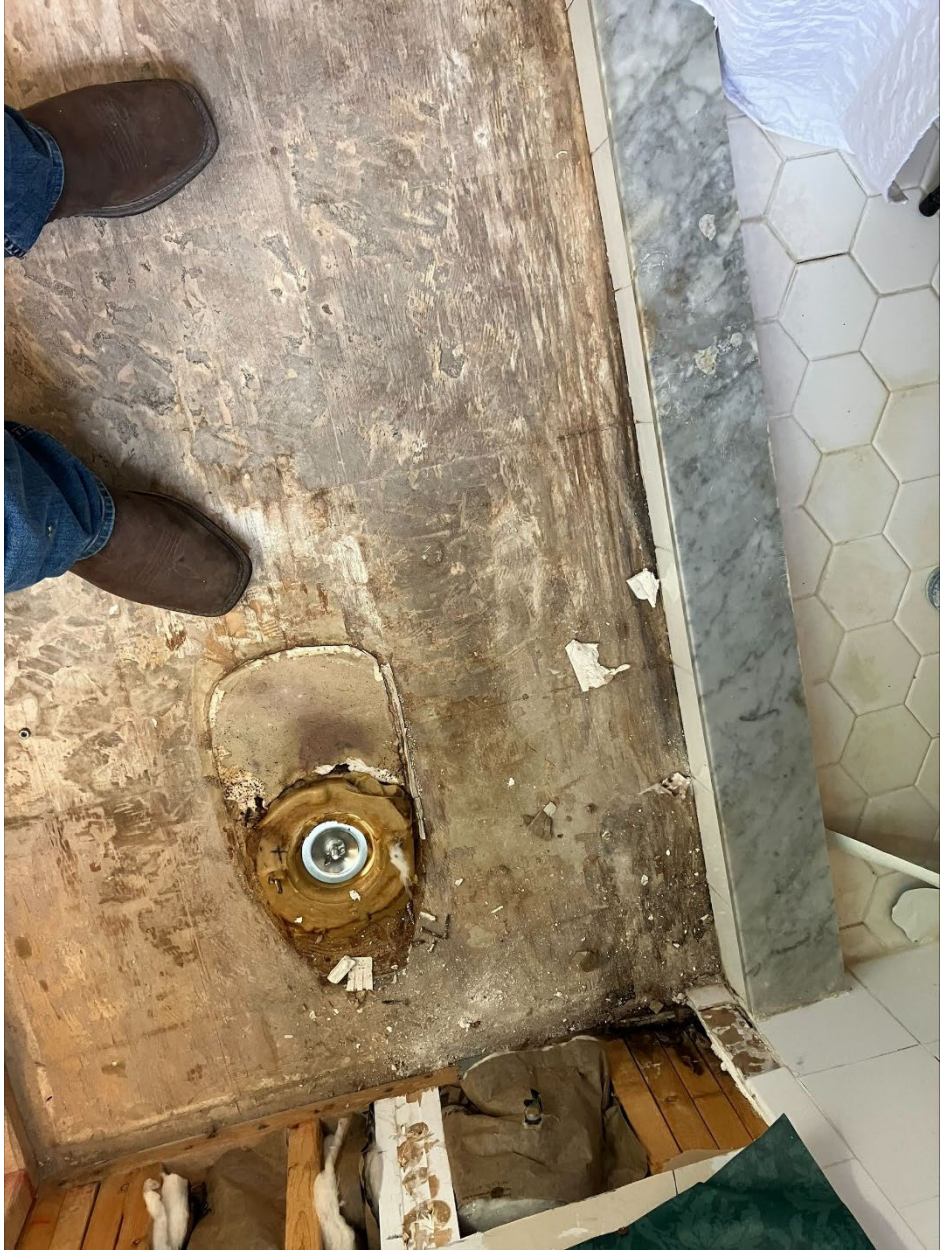
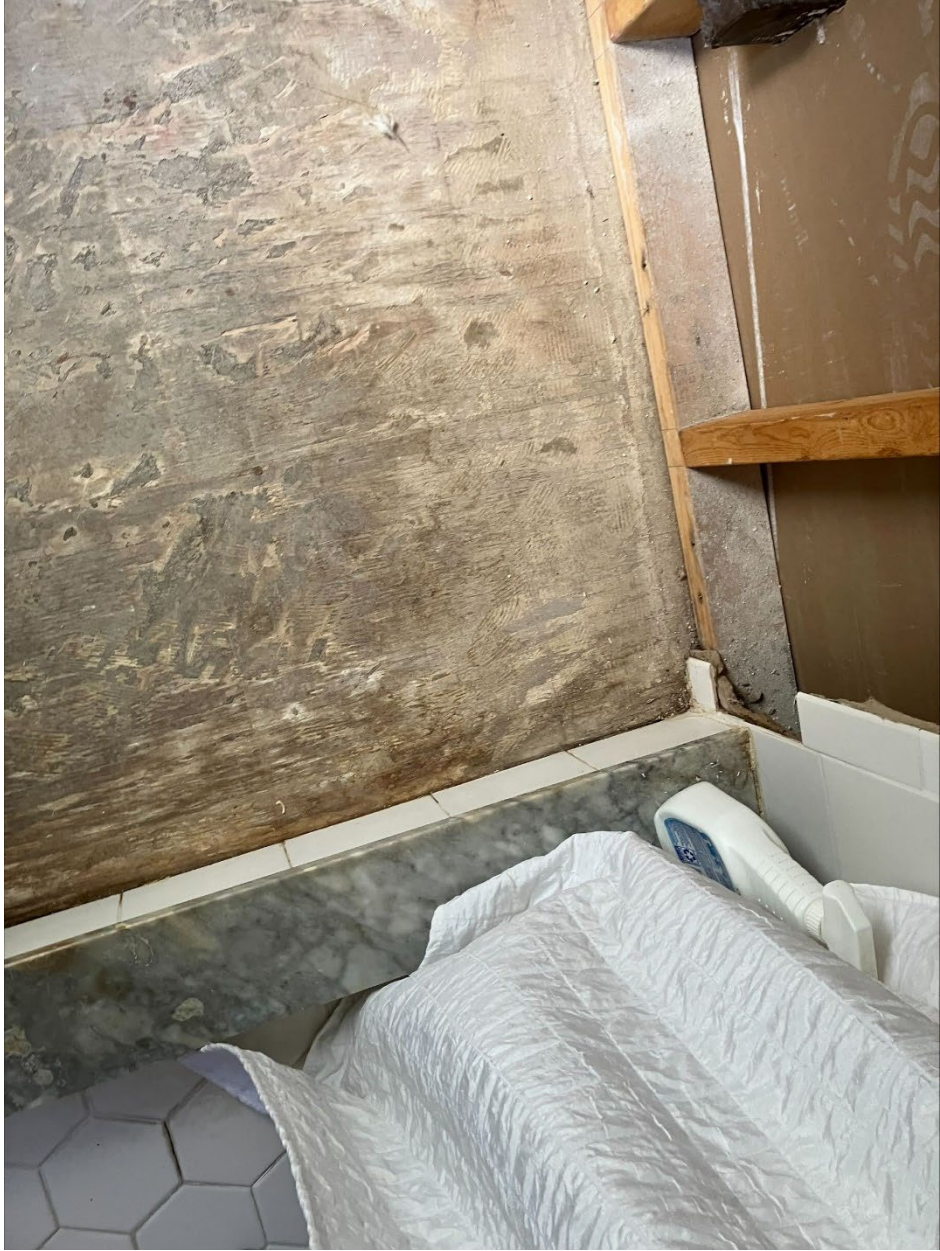
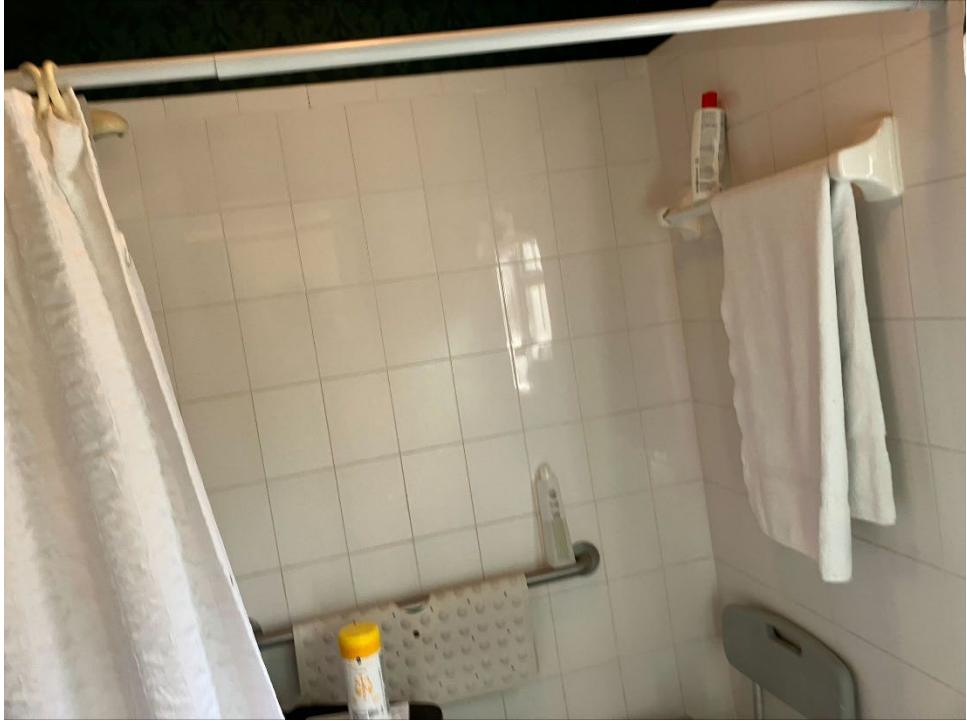
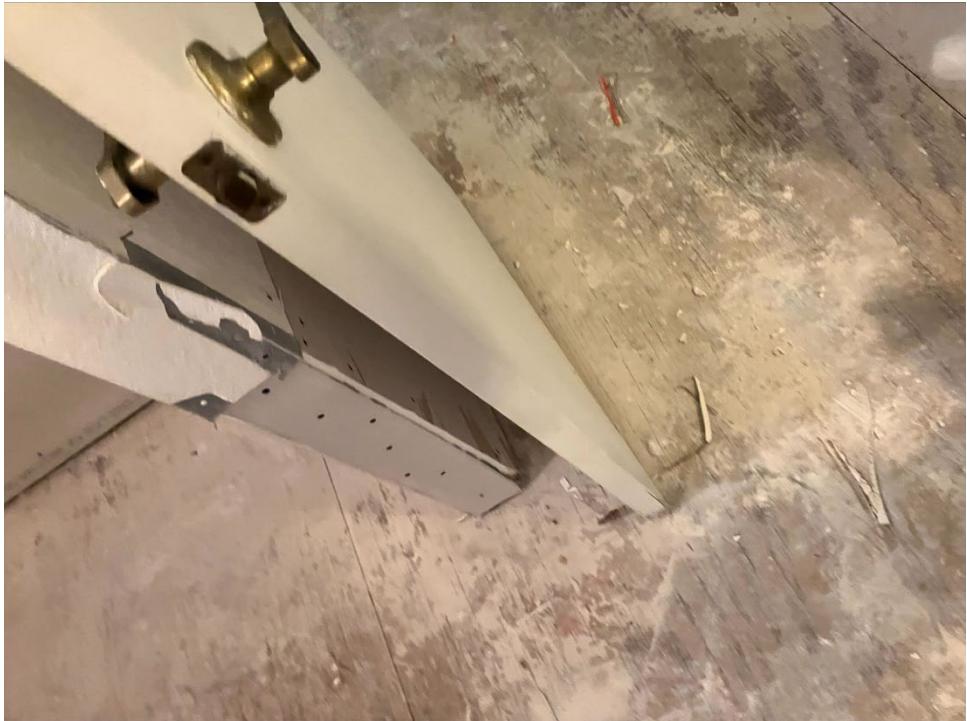
Drywall started February 9 2023

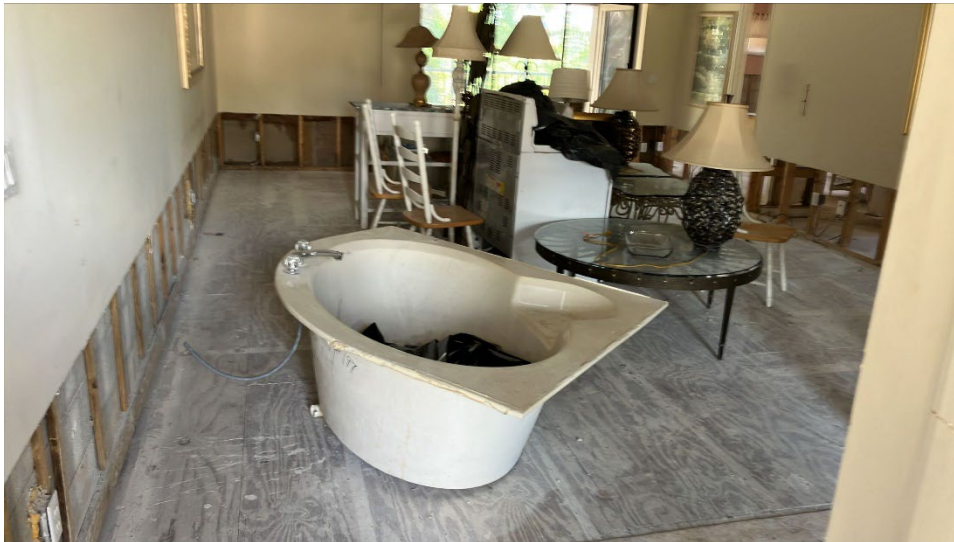
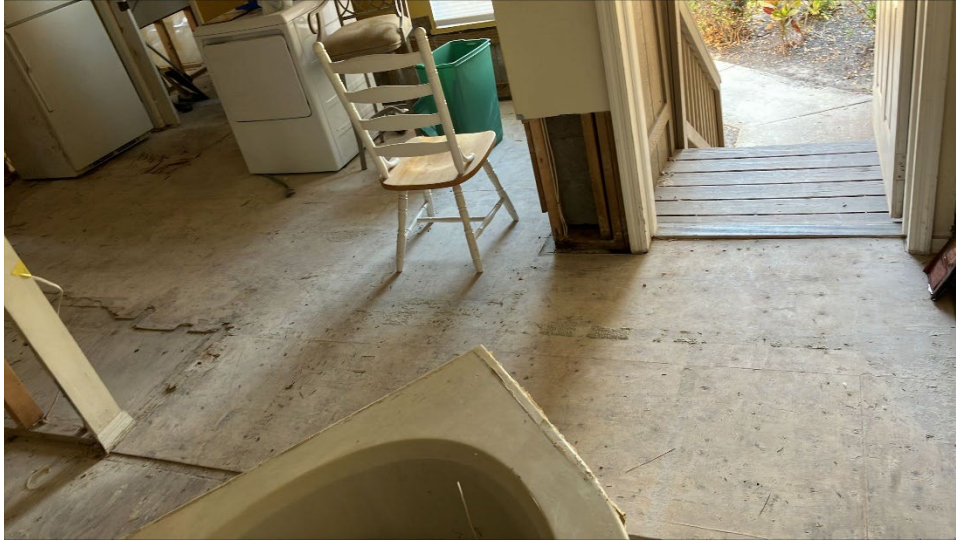
Sub flooring all throughout the kitchen

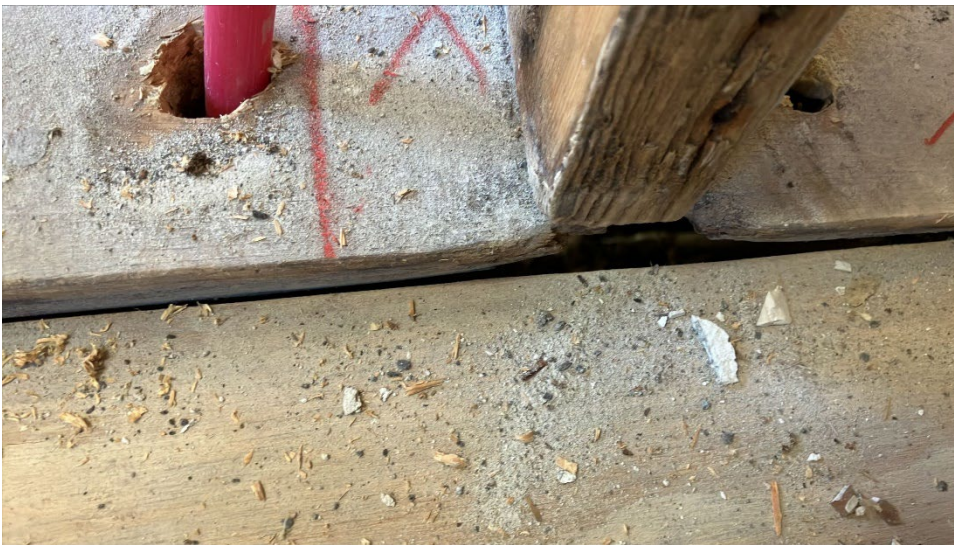
Completely rotted to 2x4 Frames and subfloor

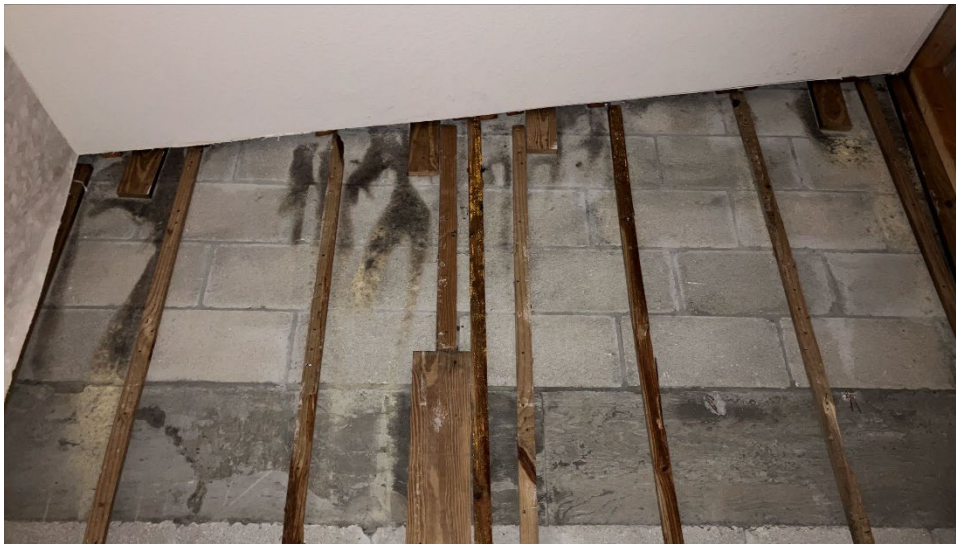
Master bathroom, potentially mold on cinder blocks

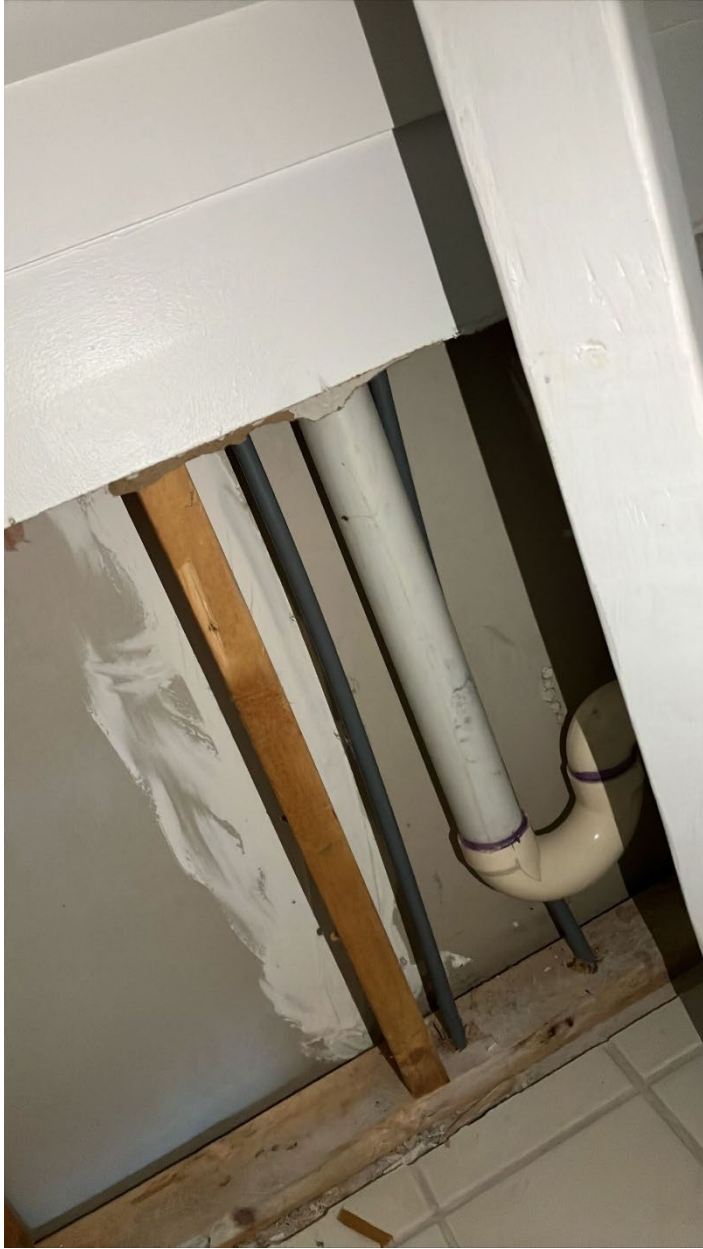
Re-pipe

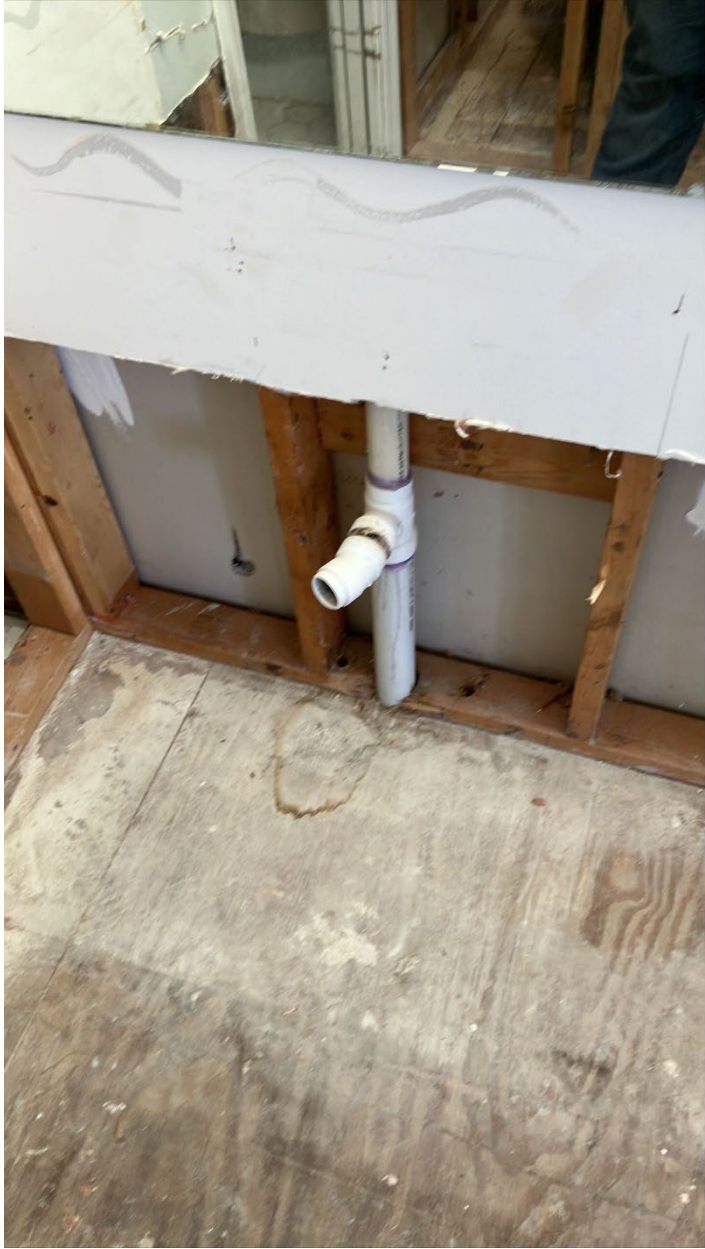
Master bathroom

Mold

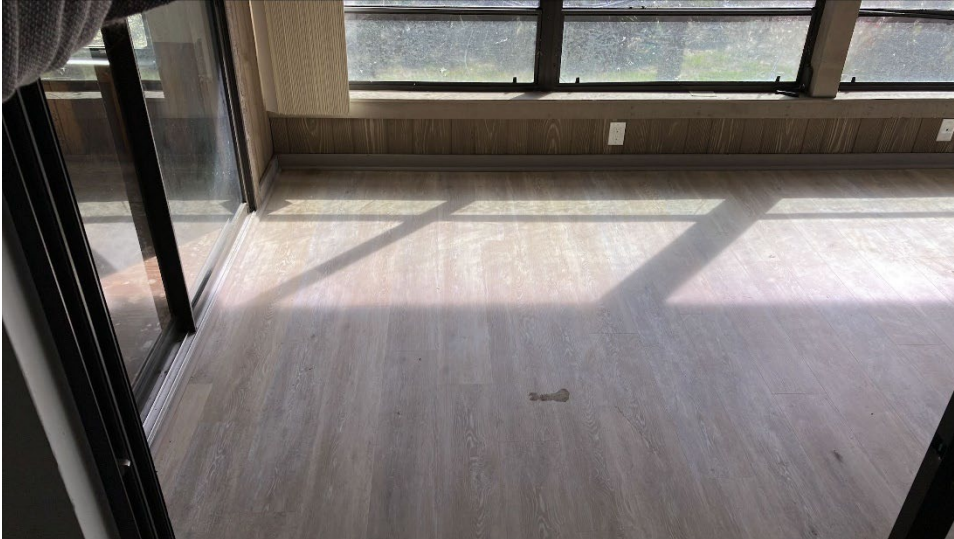
Back room ??

I need a electrician and a plumber

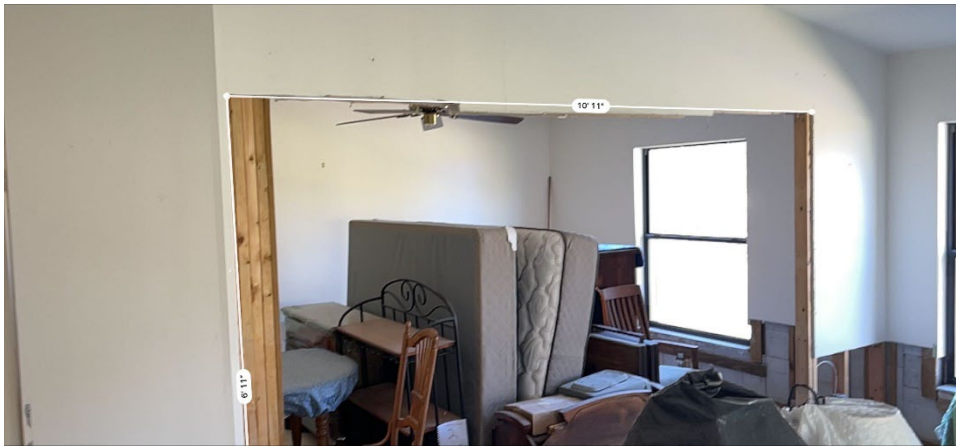
Den wall to be framed and drywalled

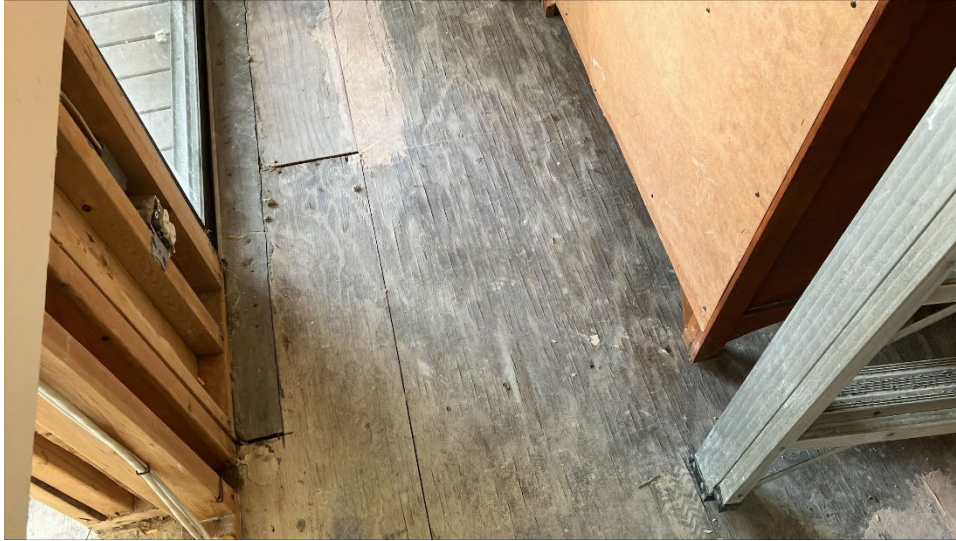
Living room area subfloor ?

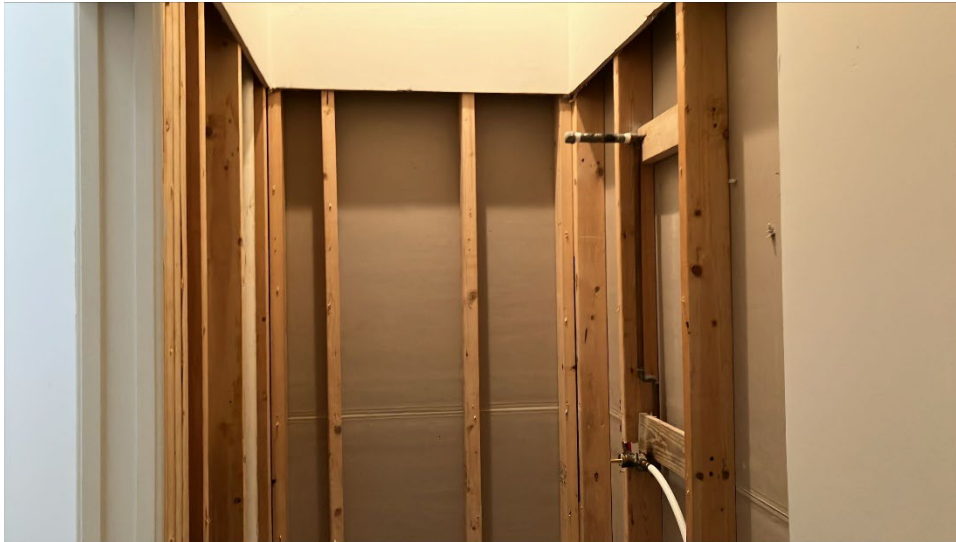
MBR sub floor?

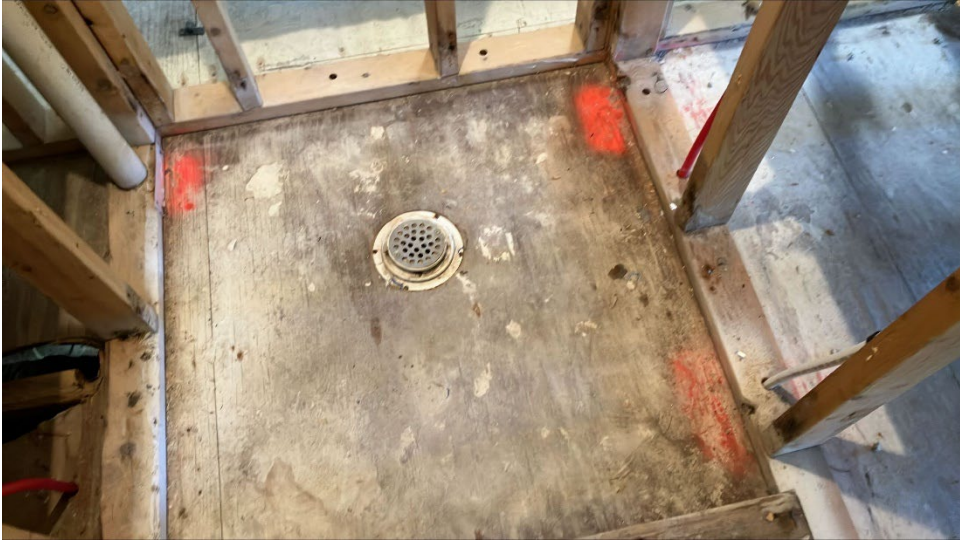
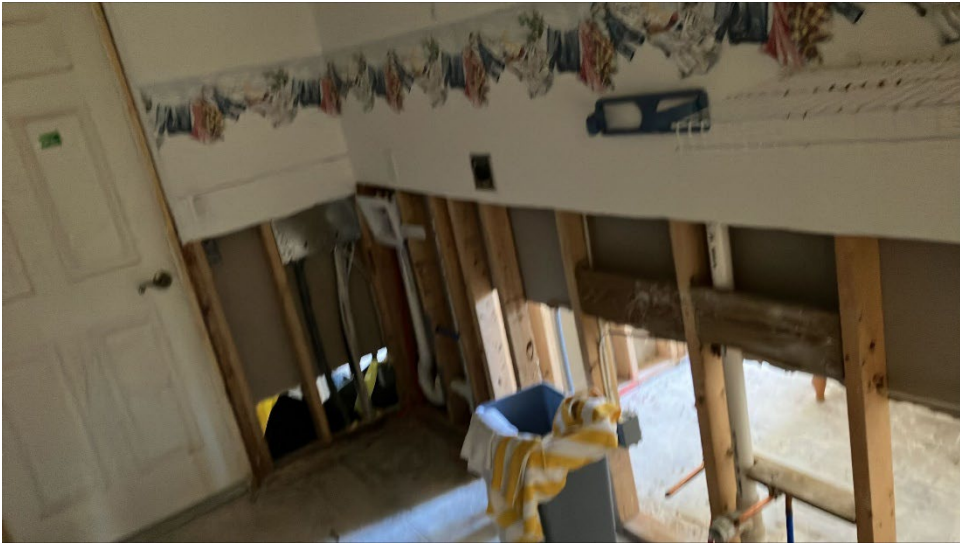
Stand up shower in master bath

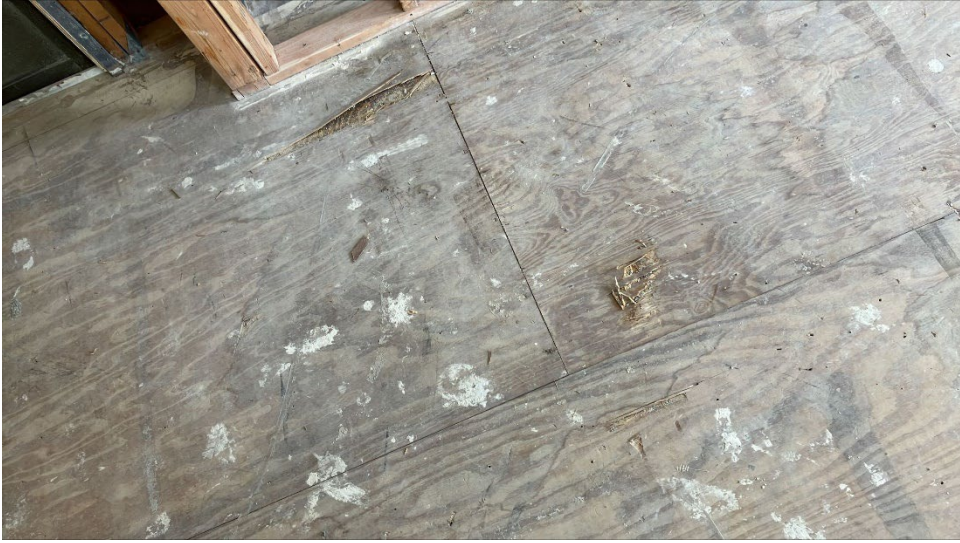
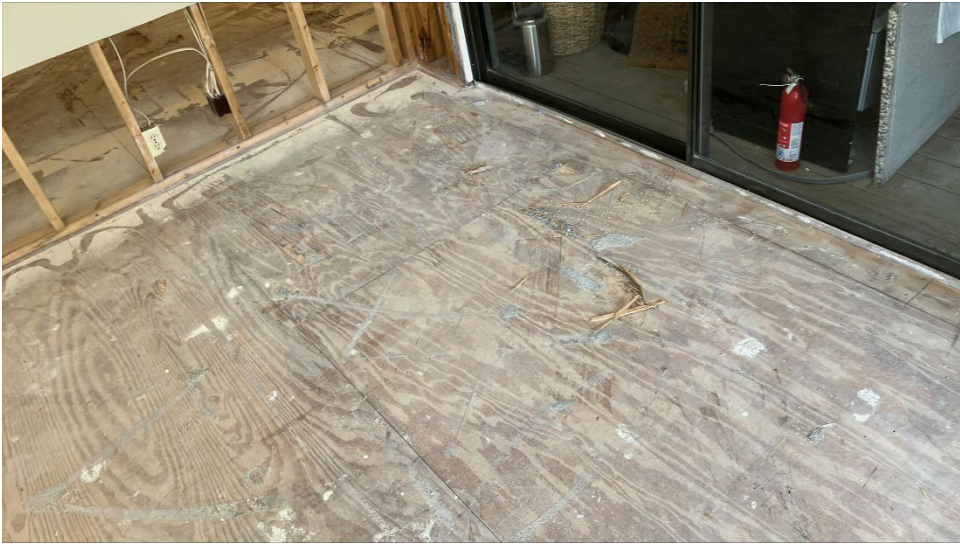
Chipped up sub-floor

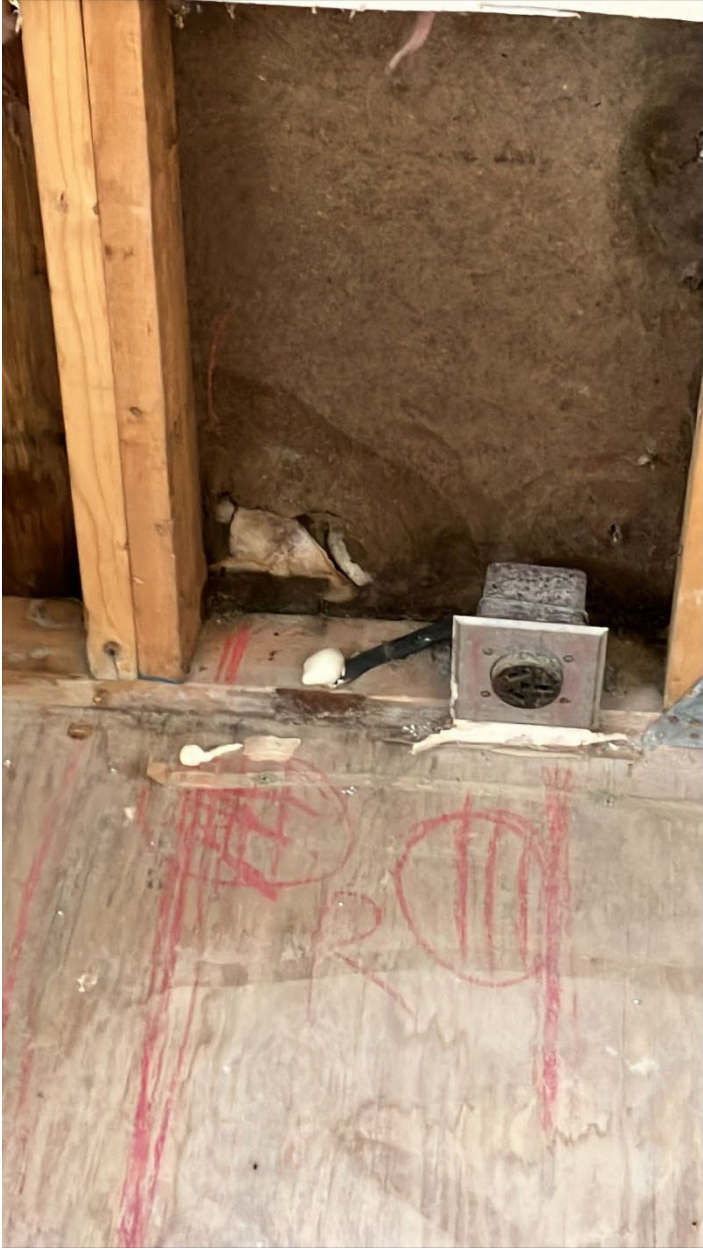
Kitchen, rotten wood sheeting

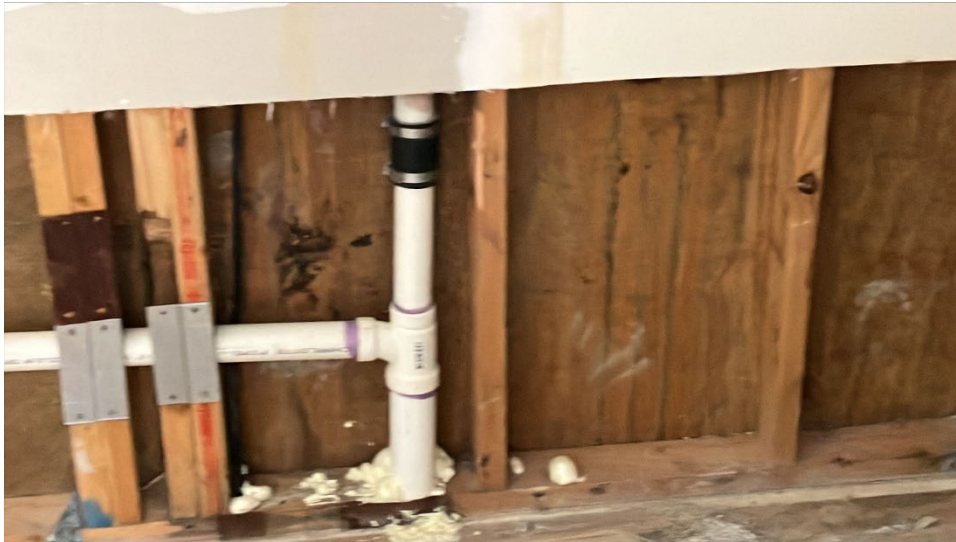
Water damage on plywood exterior in kitchen area

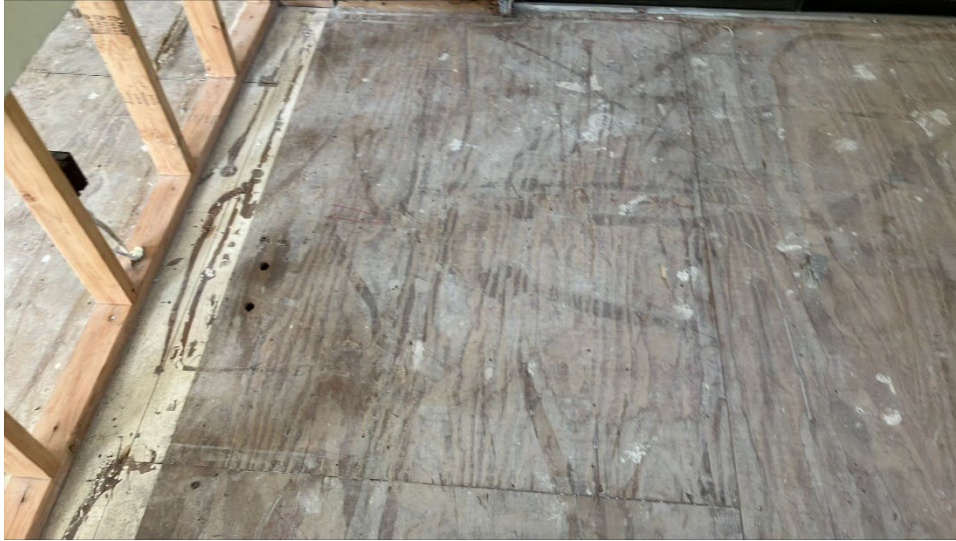
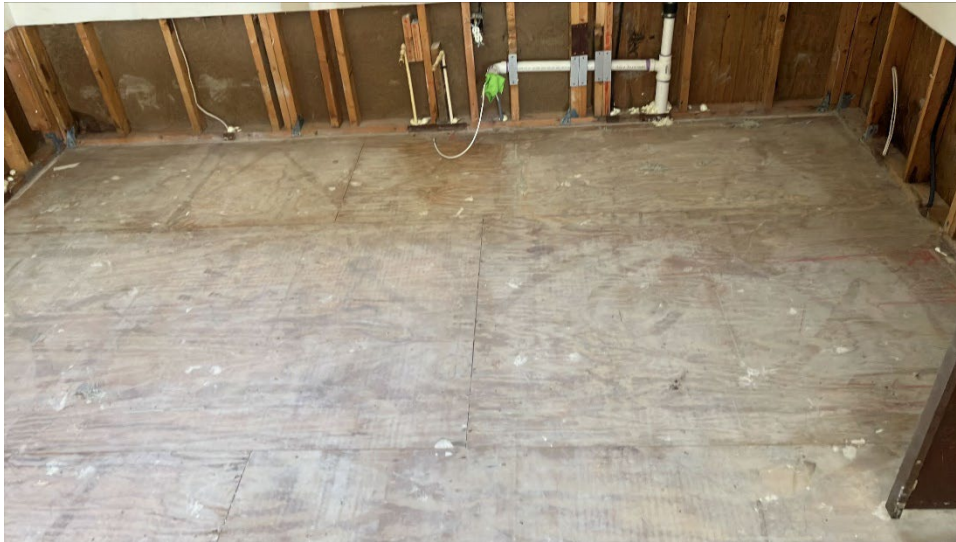
Rotted wood sheathing kitchen area

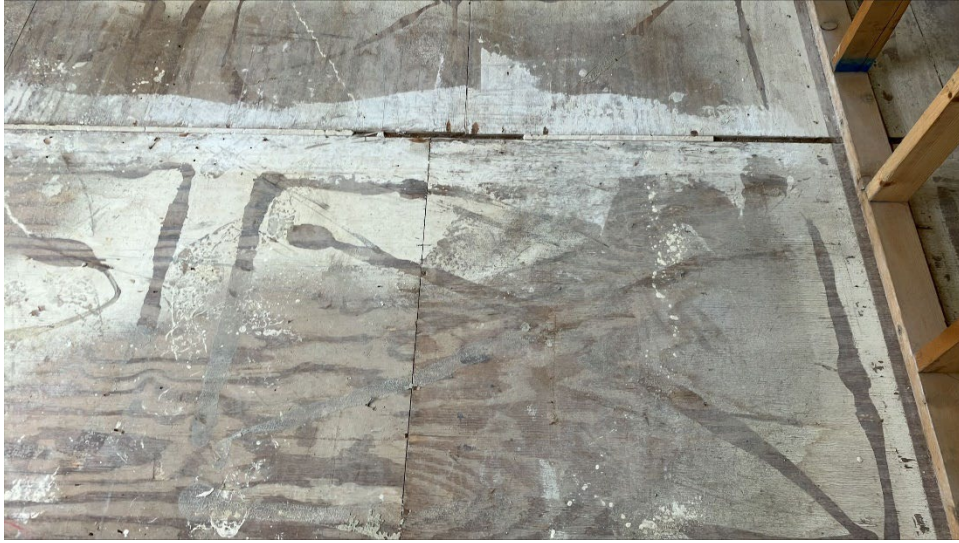
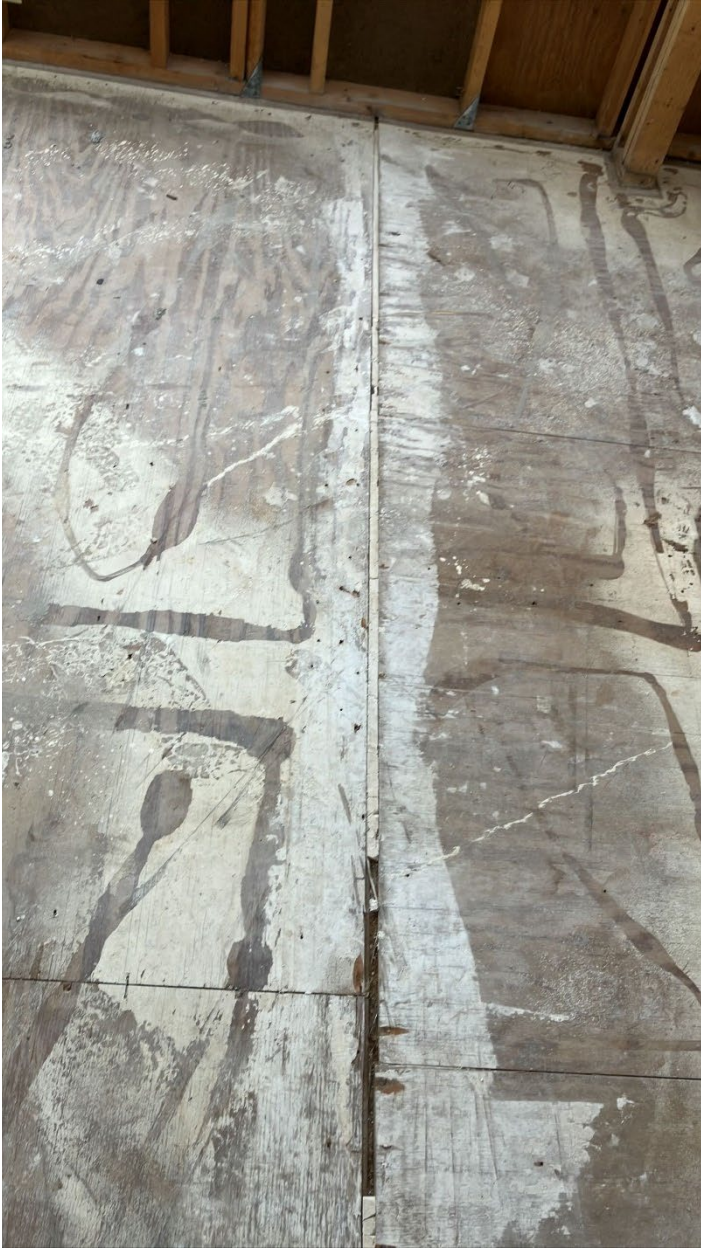
Guest bedroom, subfloor

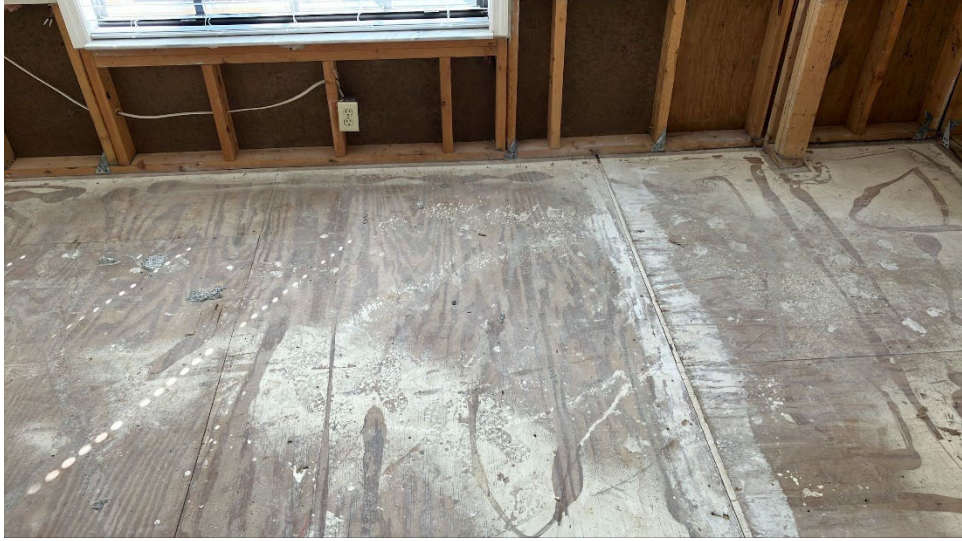
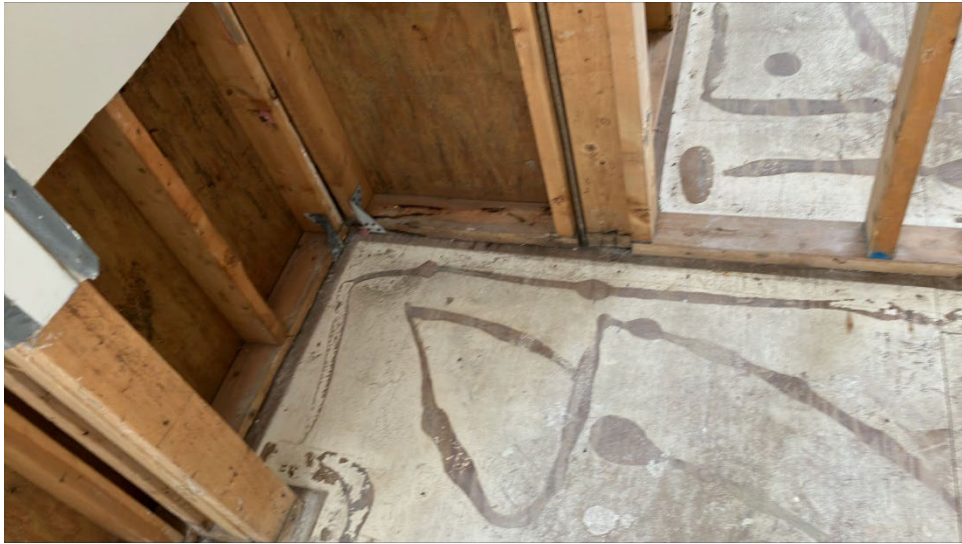
Guest bedroom one subfloor

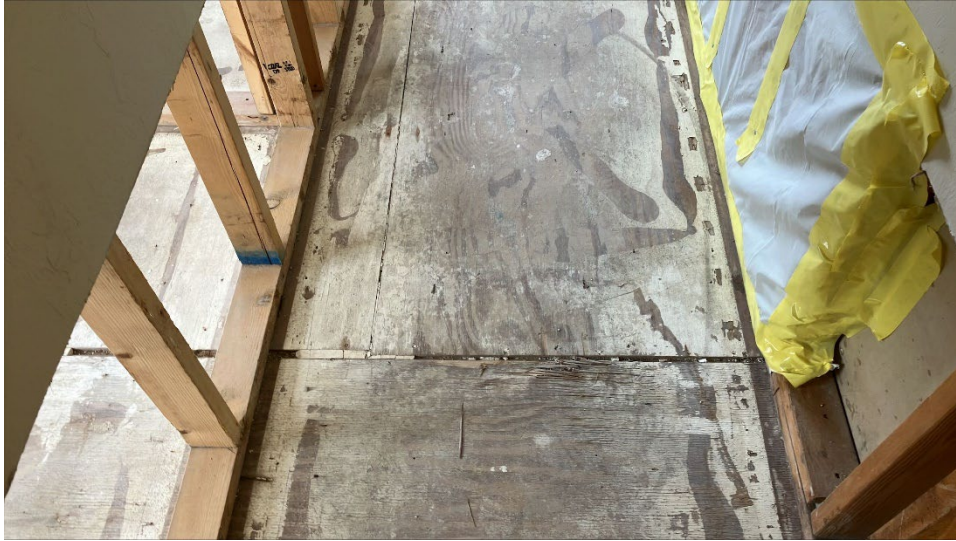
Hallway, rotted, wood, subfloor

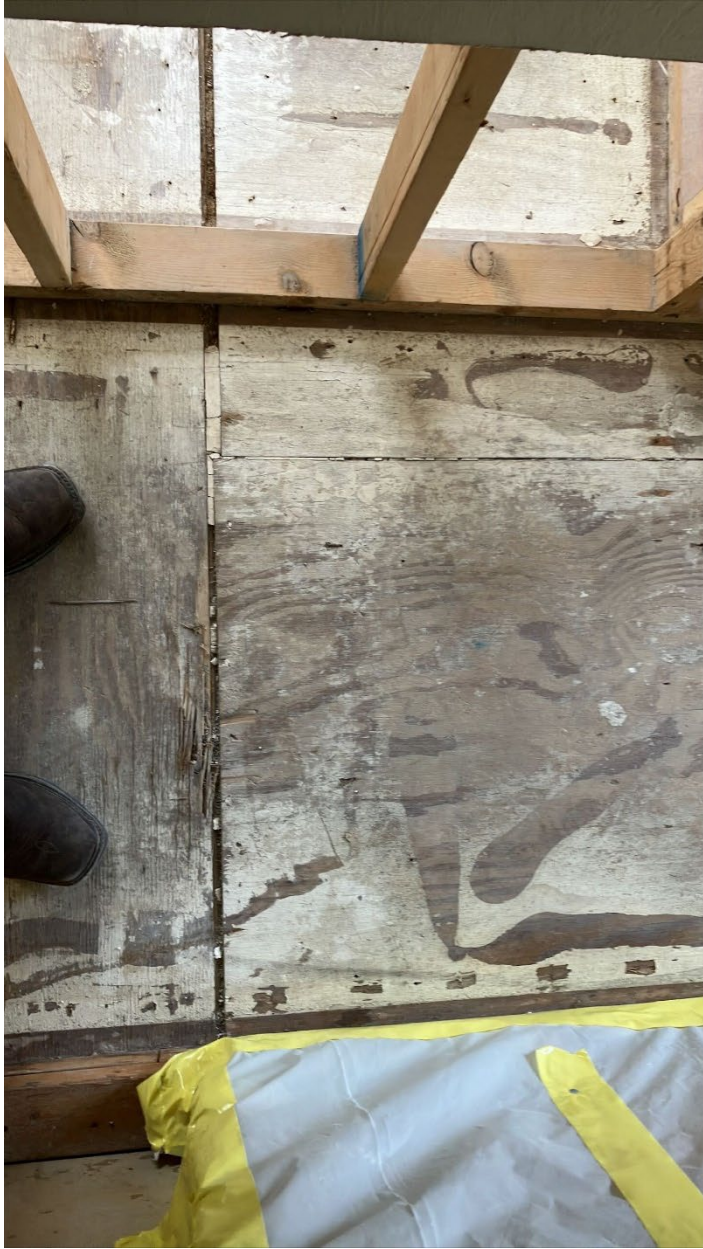
Hallway, subfloor

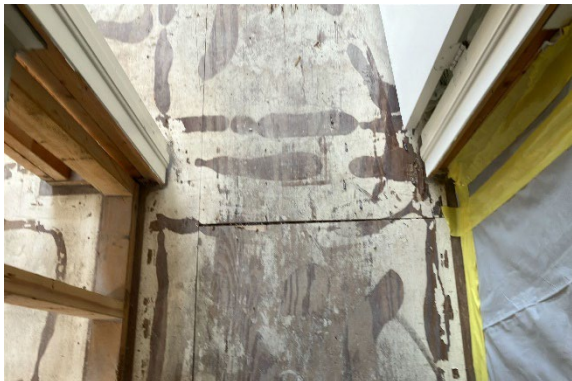
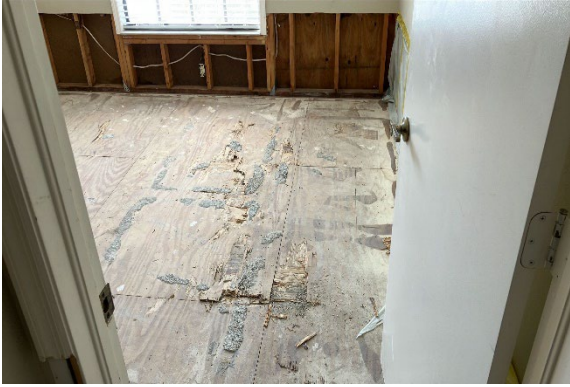
Guest bedroom two sub flooring

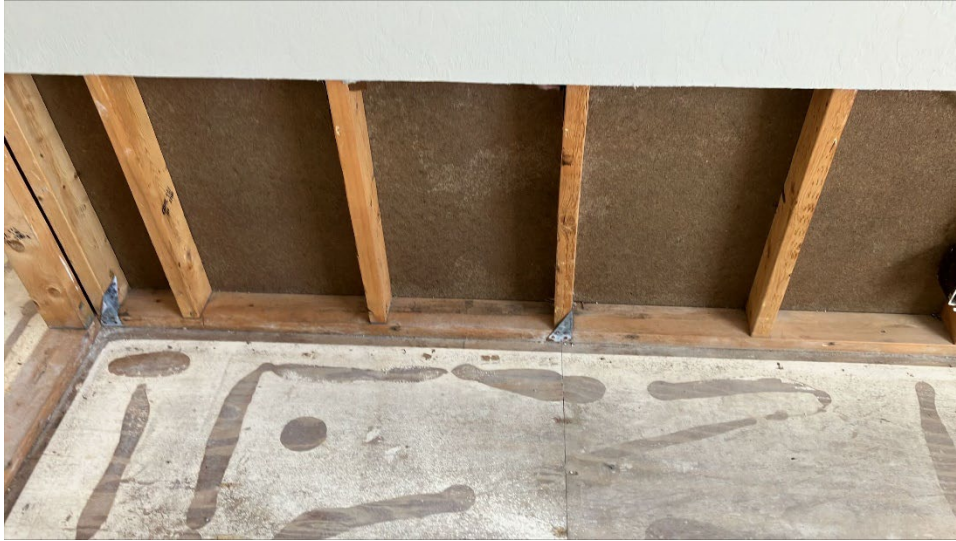
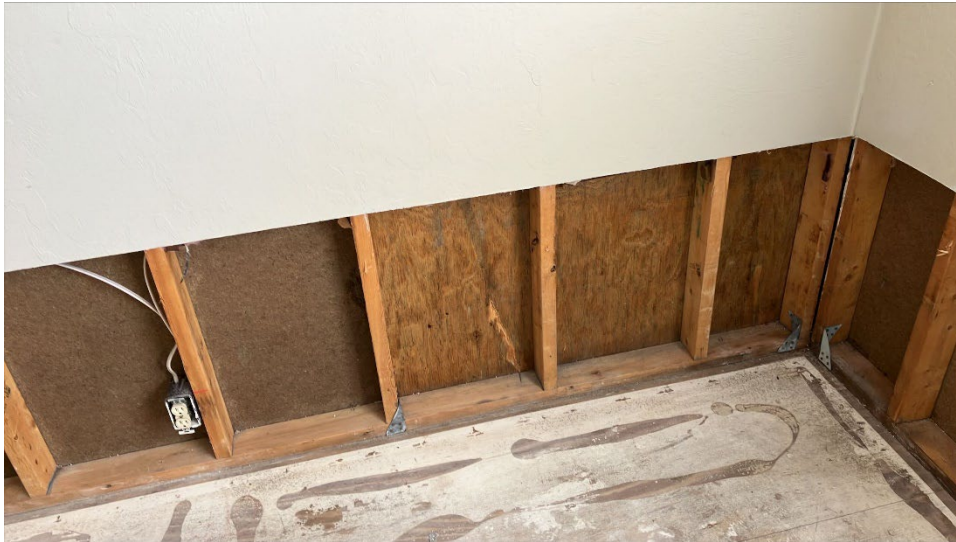
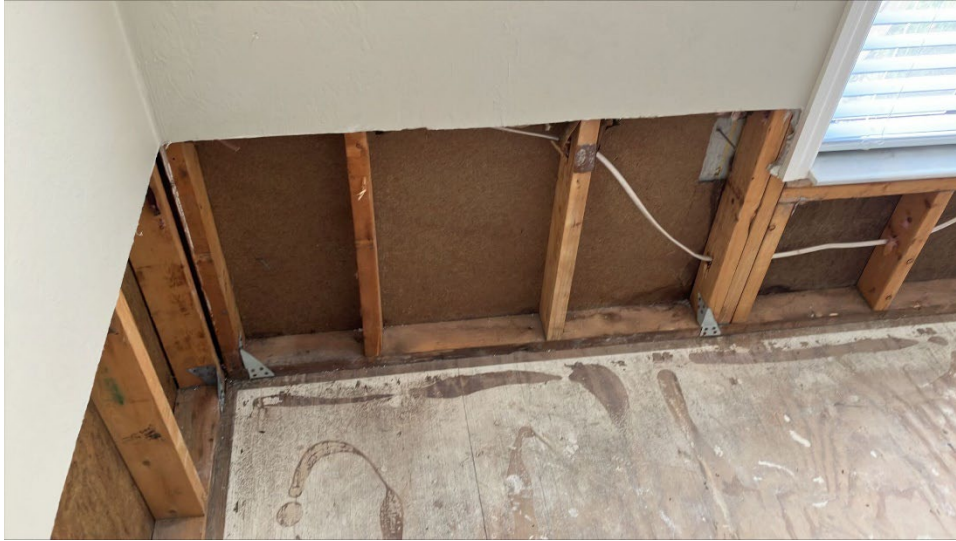
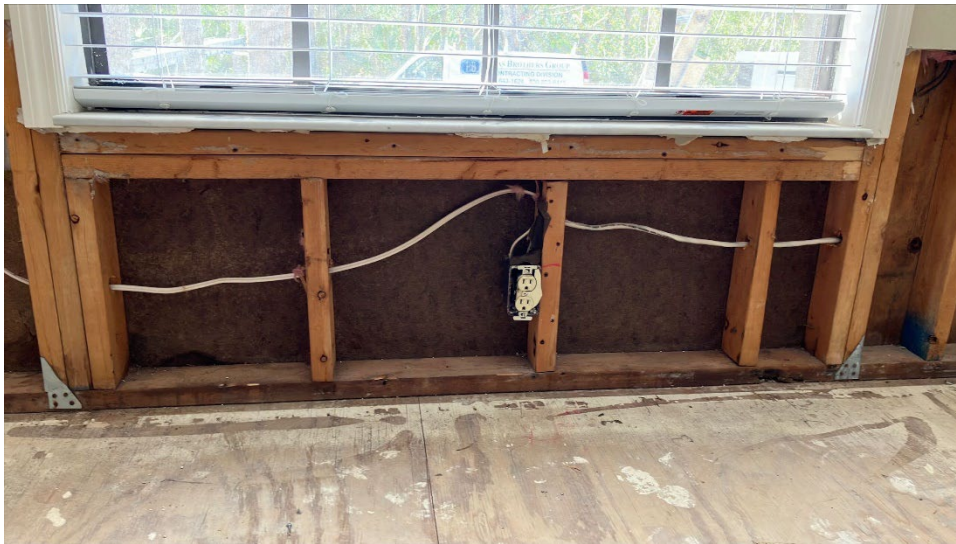
Wood sheathing has water damage

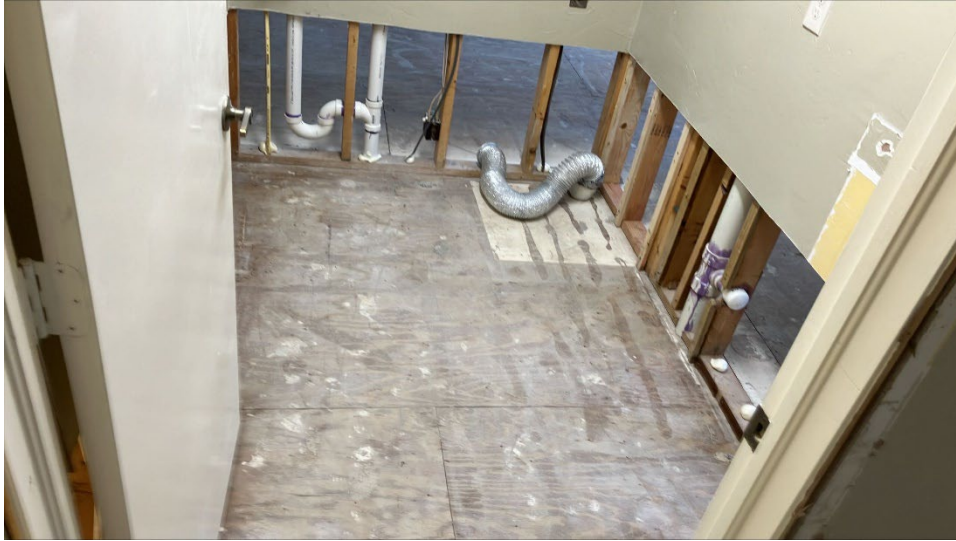
Laundry room subfloor
