The meeting started at 9:30 on 12/30/2022

**ISLAND PARK - #000074**

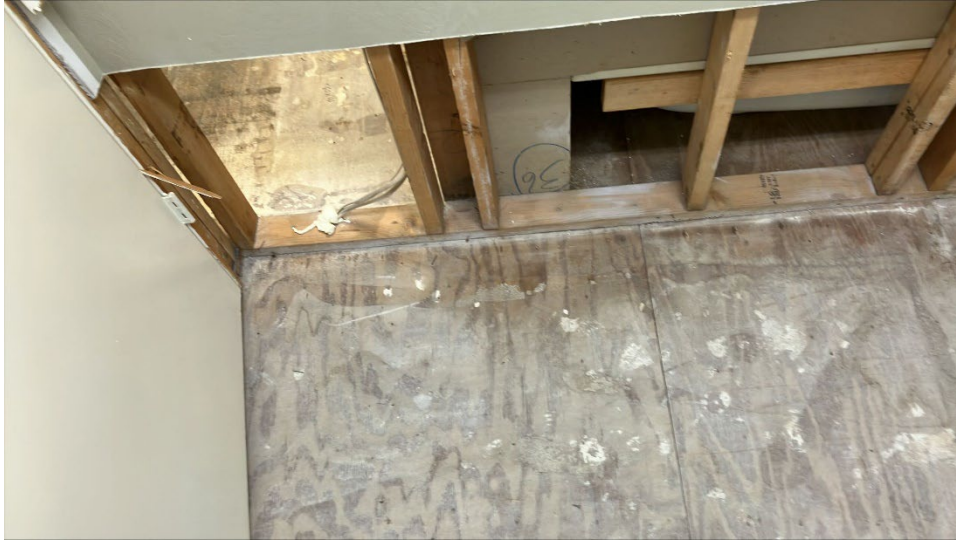
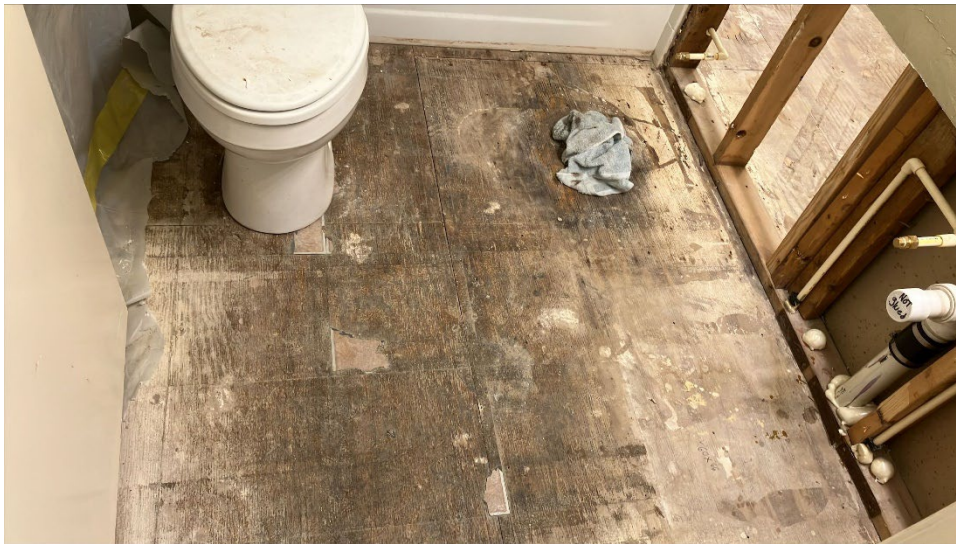
Guest bathroom, subfloor

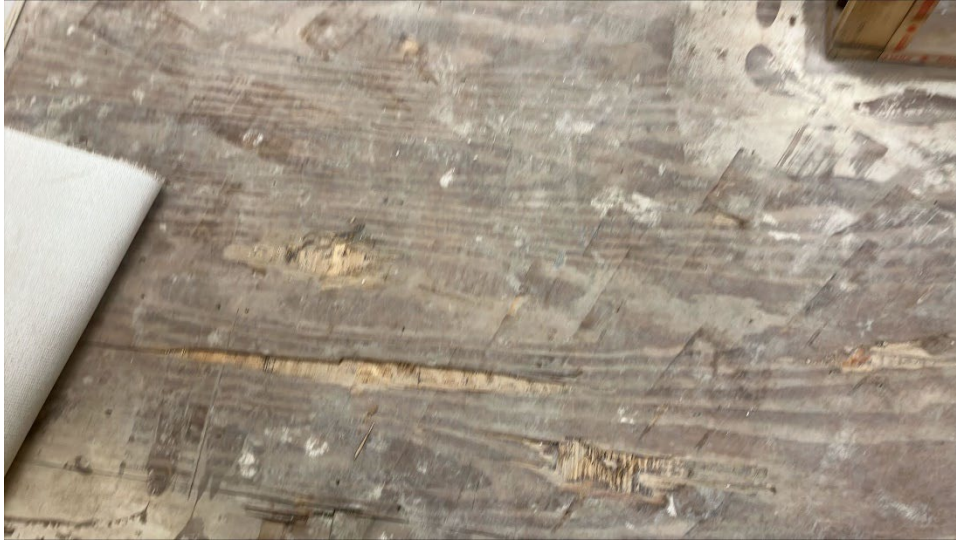
Master bathroom subfloor

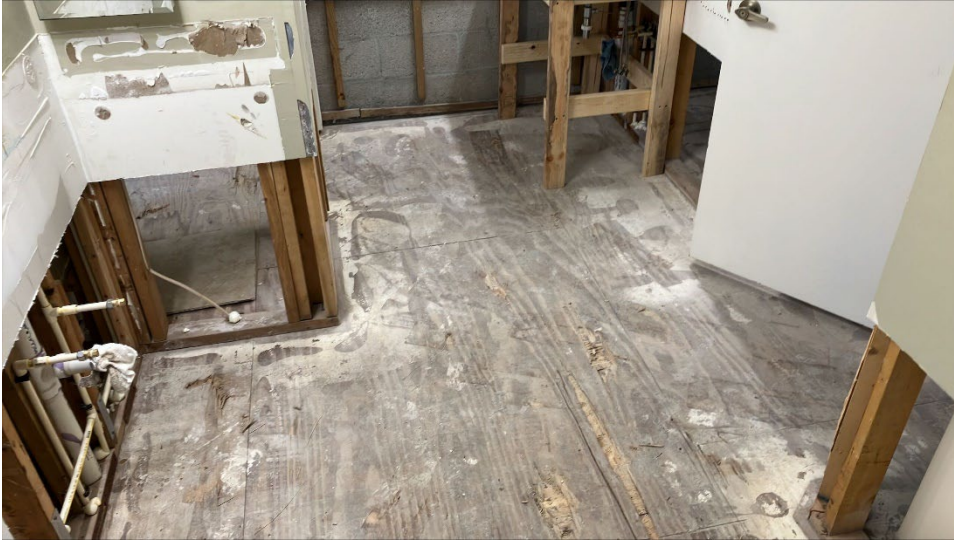
Master bathroom, subfloor

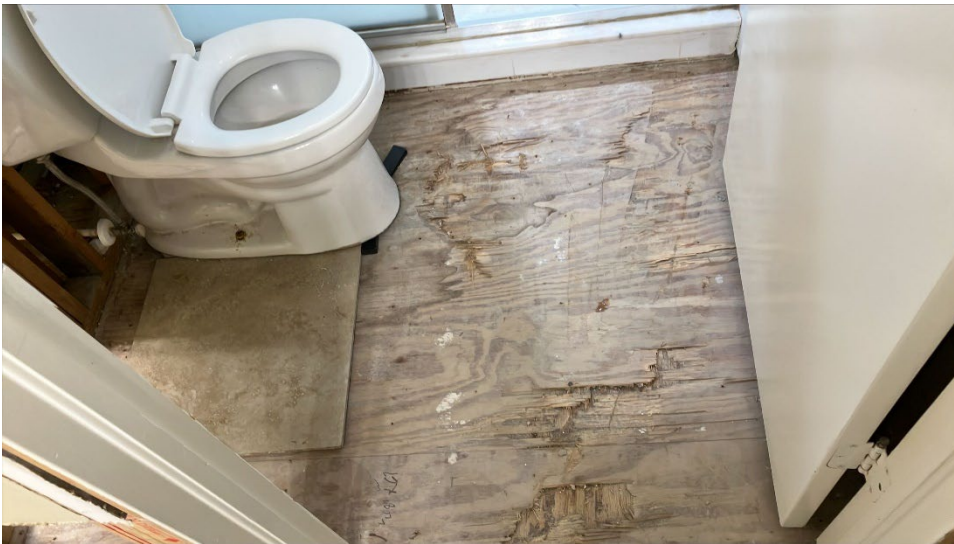
Master bathroom stand up shower area sub for

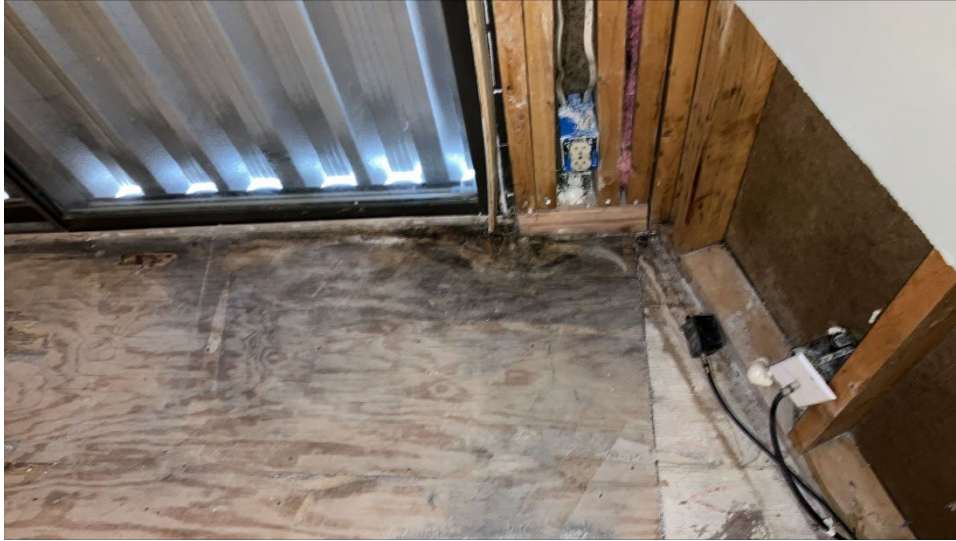
Master bedroom right side of sliding glass door, subfloor rotting

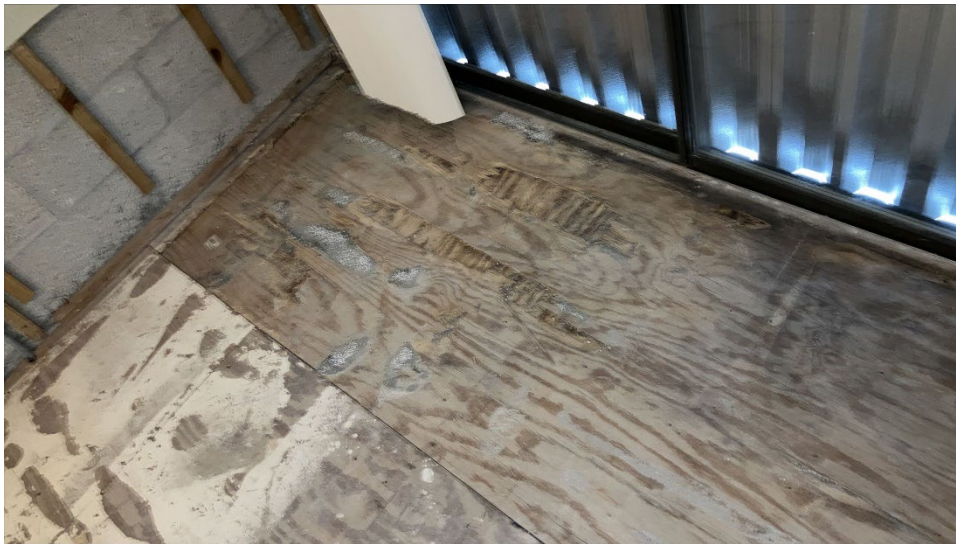
Subfloor in front of sliding glass door, master bed

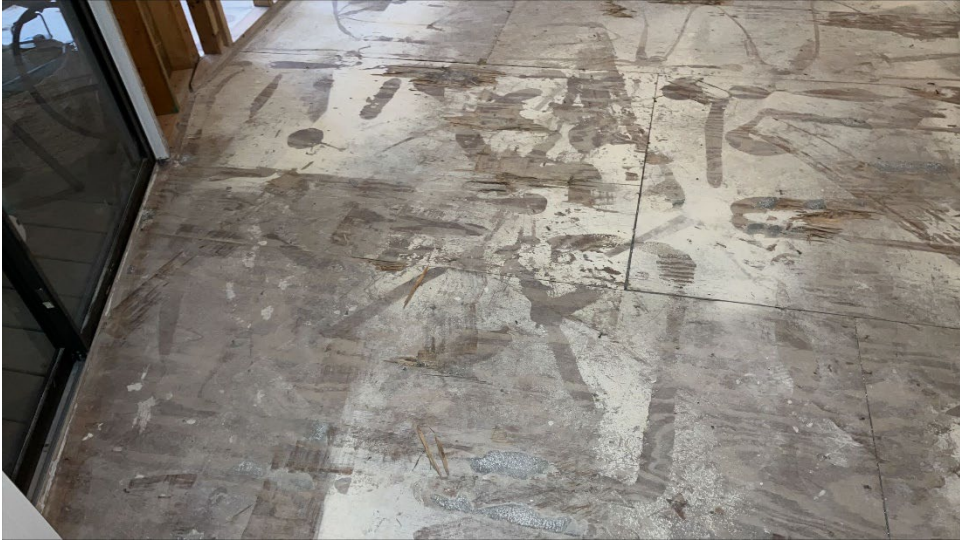
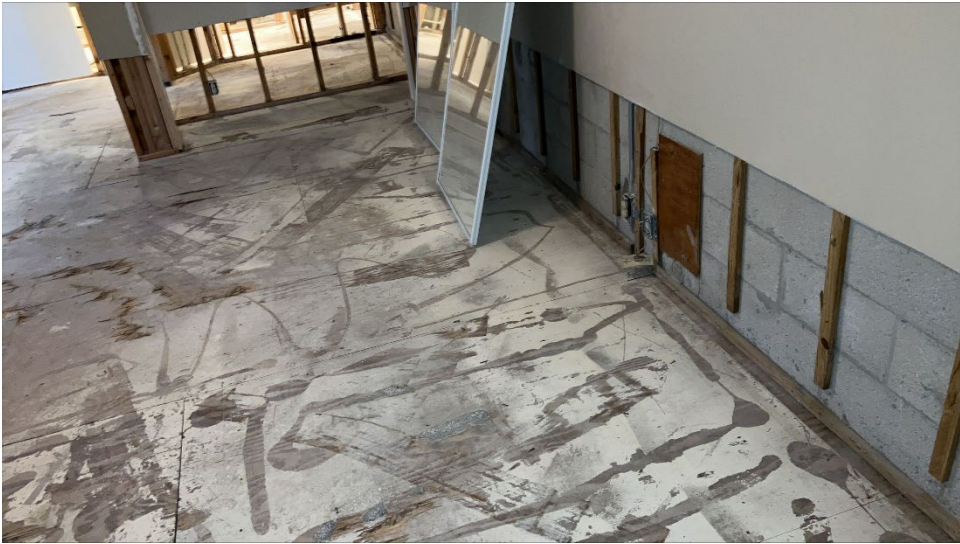
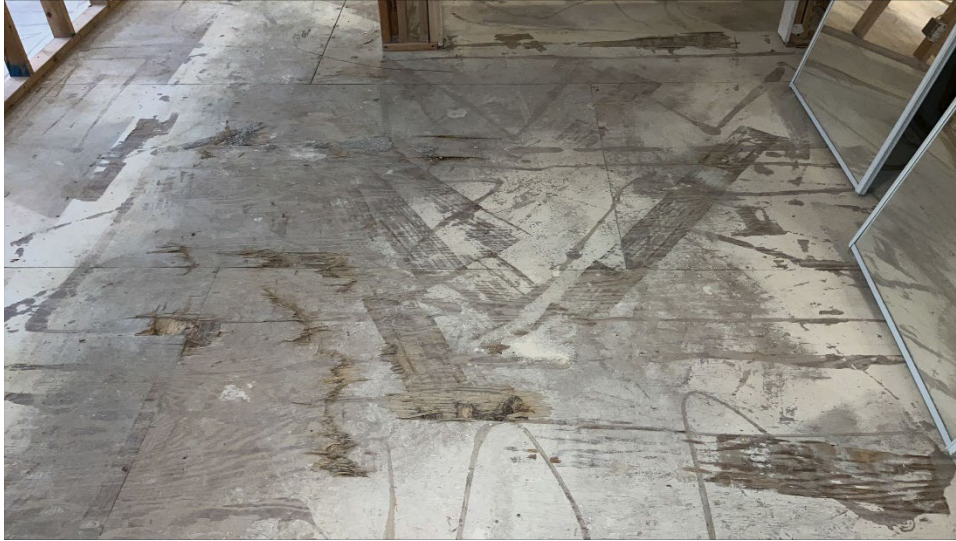
Master bedroom, closet, subfloor

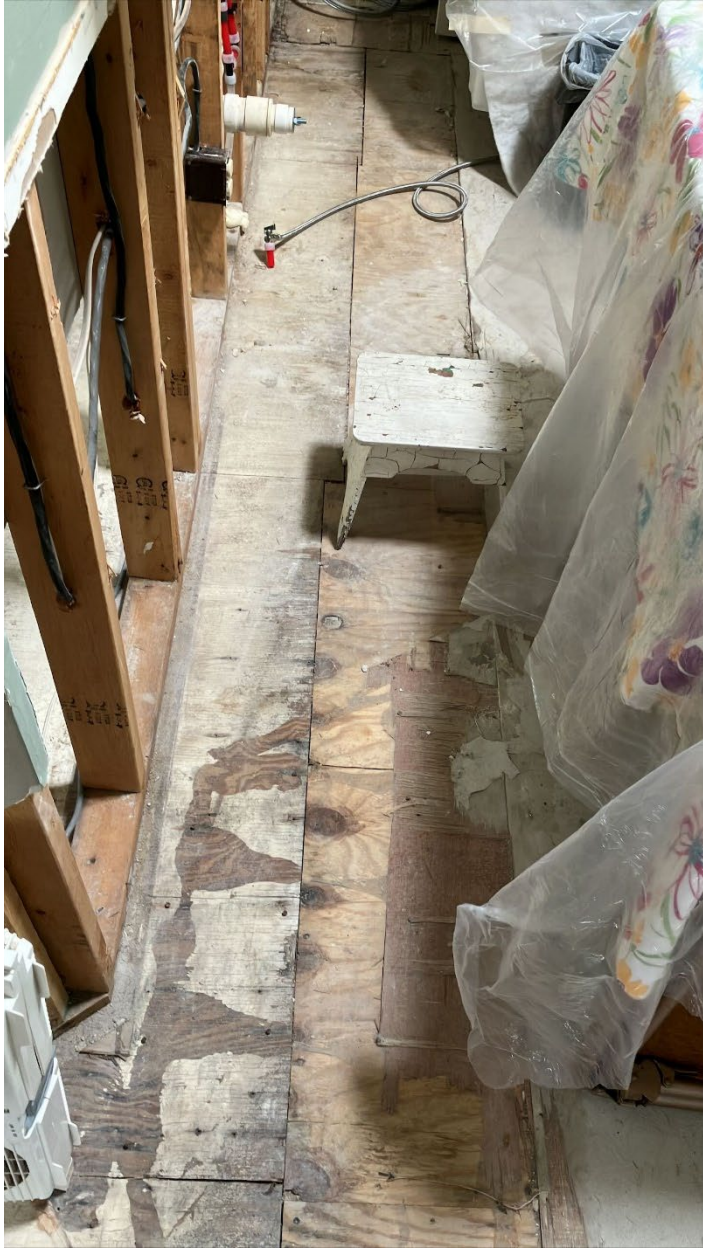
Sub flooring in kitchen

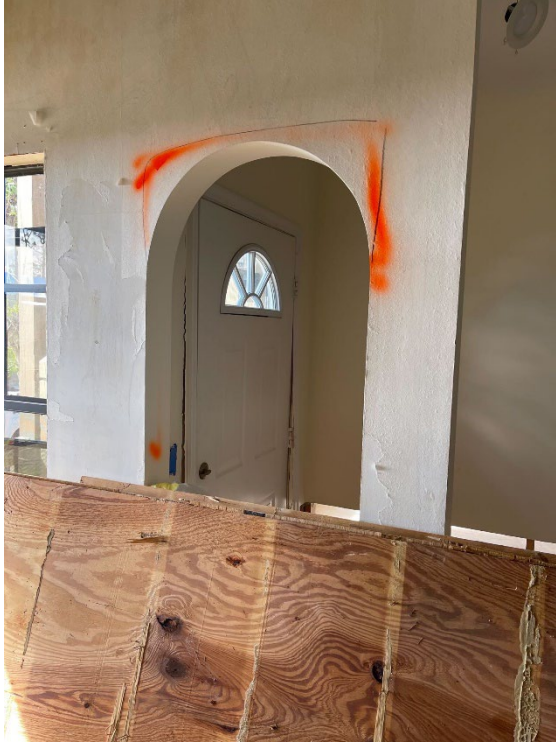
Under living room window, wood sheathing

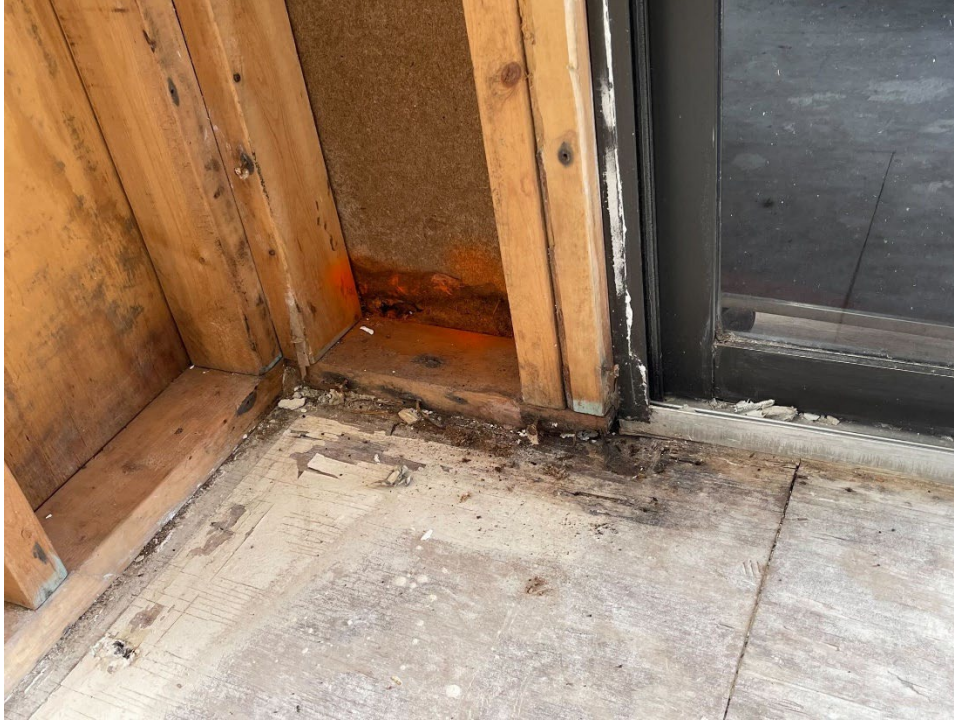
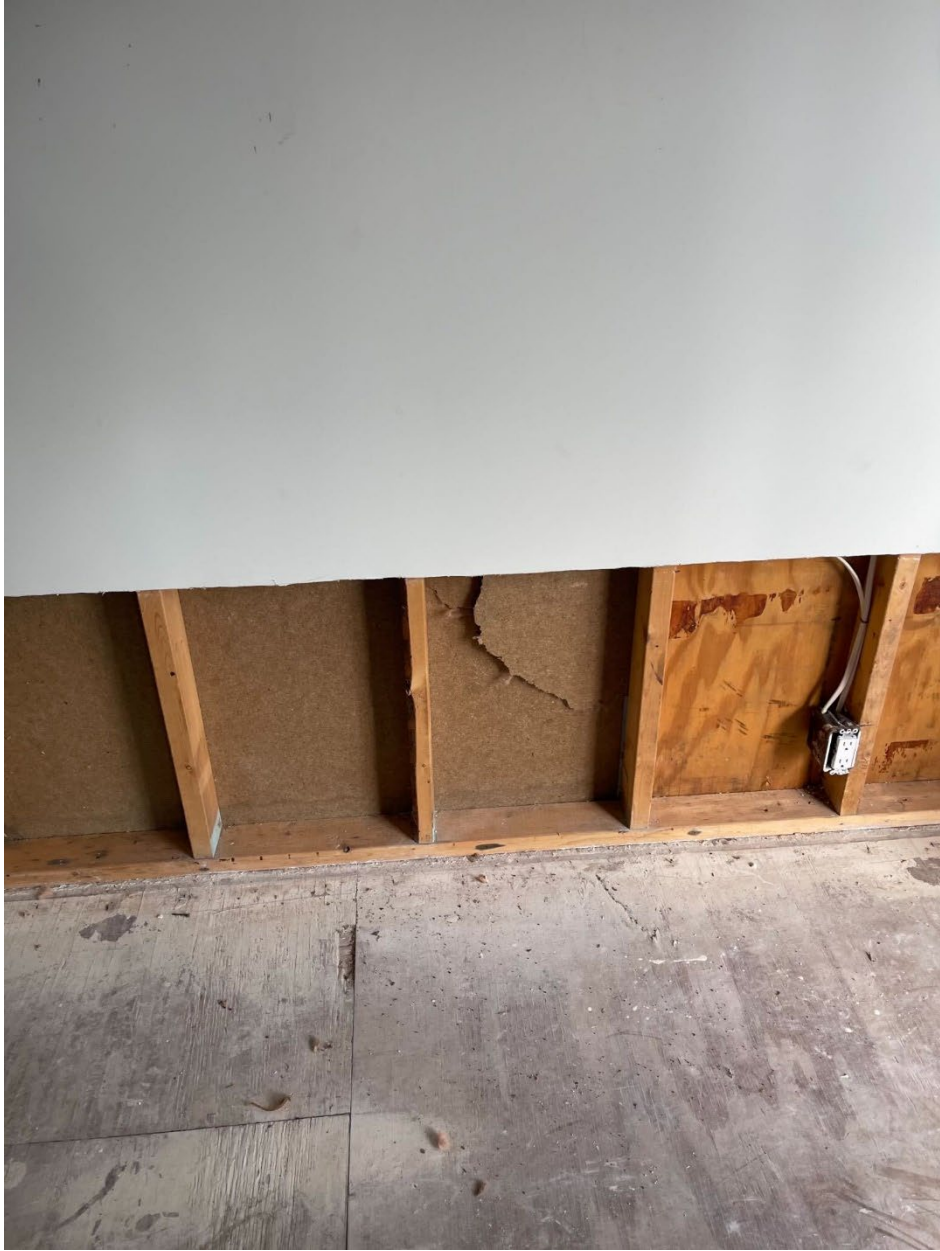
Left and right side of the floor and wood sheathing next to sliding glass door and several other spots in master bedroom.
